Comanche Creek Assessment Report

Presented by: The Quivira Coalition

For: The Environmental Protection Agency and the New Mexico Environment Department – Soil Water Quality Bureau

Grant Title: Comanche and Cordova Creeks Watershed Restoration Action Strategy, Education and Restoration Project, Project Number C9-996101-009-01; Contract Control # 02 667 5000 0007

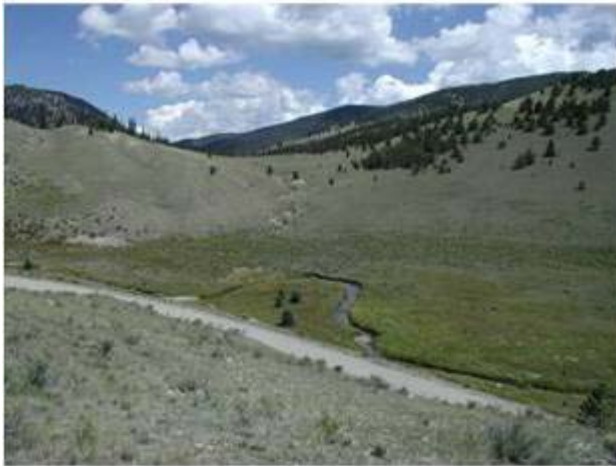
MPP#1 South Side Facing 25° NNE NAD 27
UTM 47 1970/4075673 for drainage cut

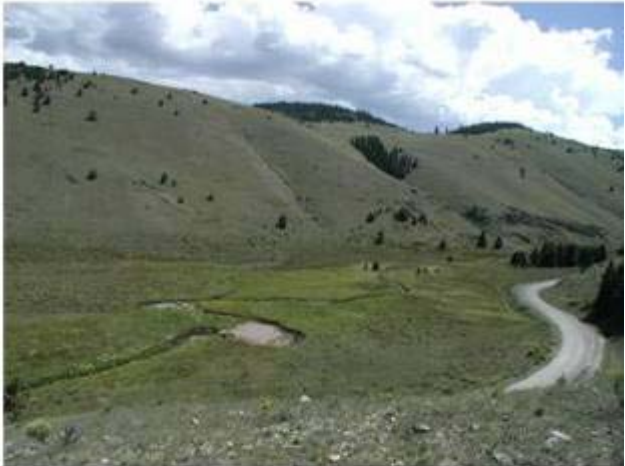
MPP#2 South Side Facing 70° ENE
Gravel bars upstream on Comanche Creek

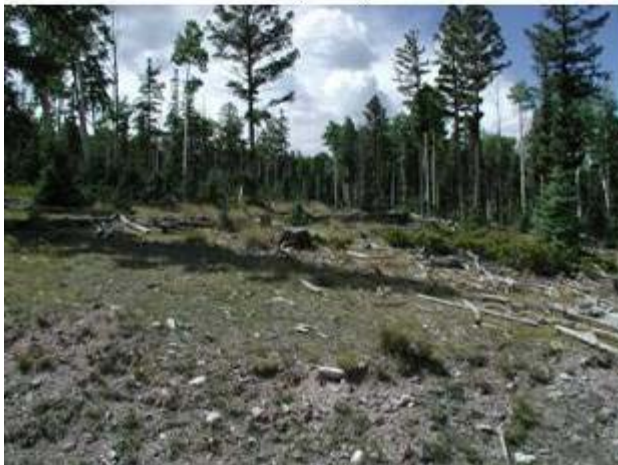
HRP#4 UTM 470997/4689 yarding area

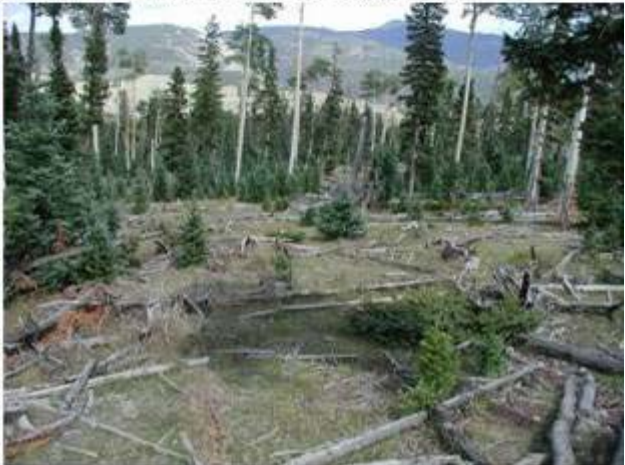
HPR#6 UTM 470896/4074313 Logged area

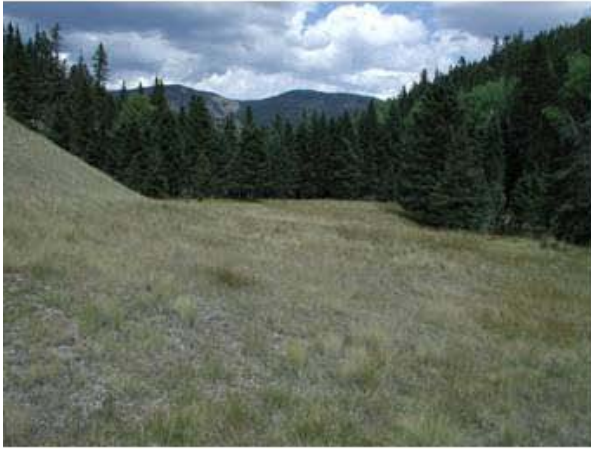
HPR#7 UTM 471126/4073720 Fernandez Creek Looking Down Meadow, Browsed *potentilla*
Spring flowing @ approximately 0.2 CFS
Spring UTM 471103/4073690

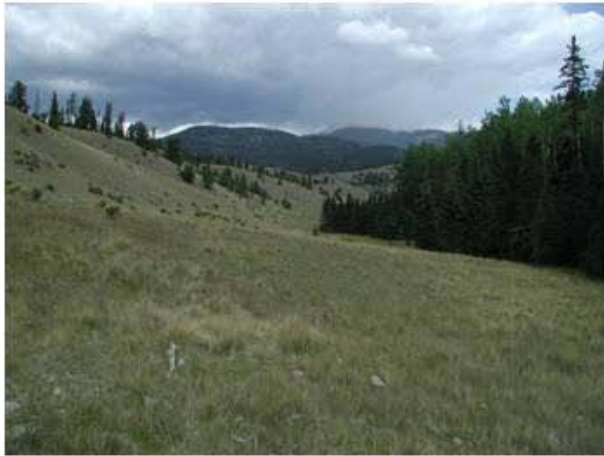
HPR#9 UTM 471406/4073925 Top of Fernandez Creek

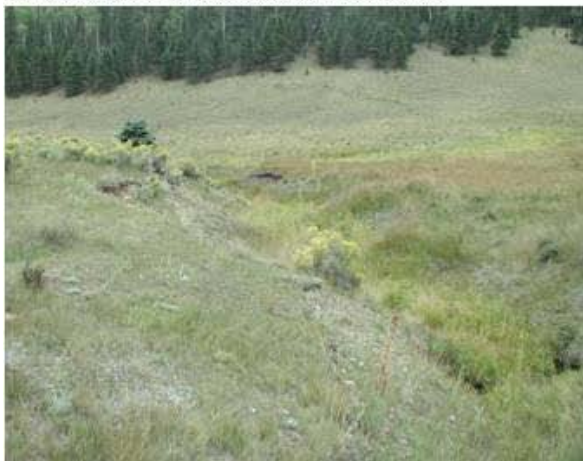
HPR#11 UTM 472075/4073999 Fernandez Creek Healing, bank erosion looking down Creek

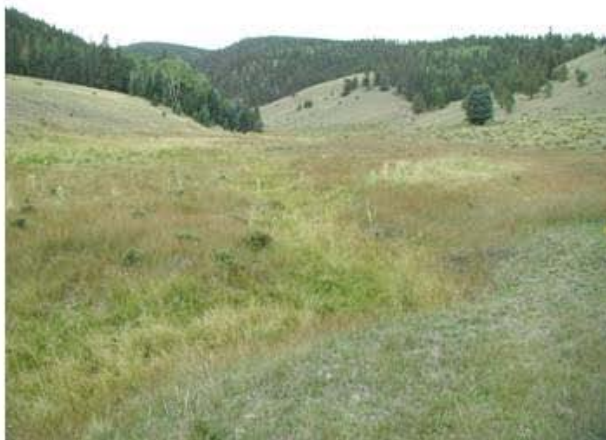
HPR#12 UTM 472075/4073999 Fernandez Creek Healing bank erosion, looking up Creek

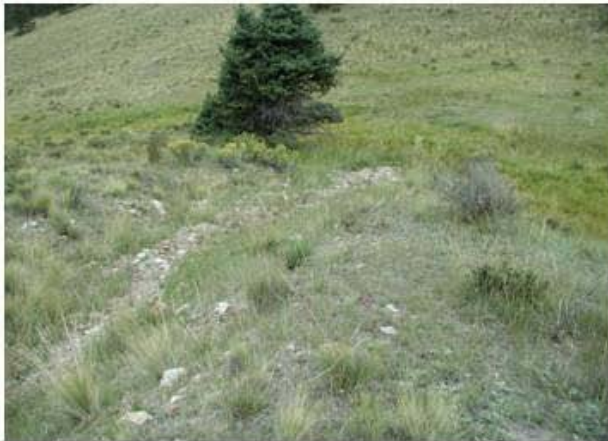
HPR#15 UTM 472351/4074045 side cut stopped by vegetation

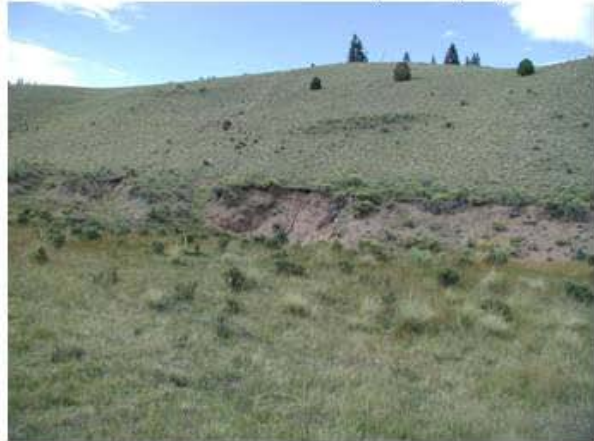
HPR#16 UTM 472636/4074110 Big eroding slope

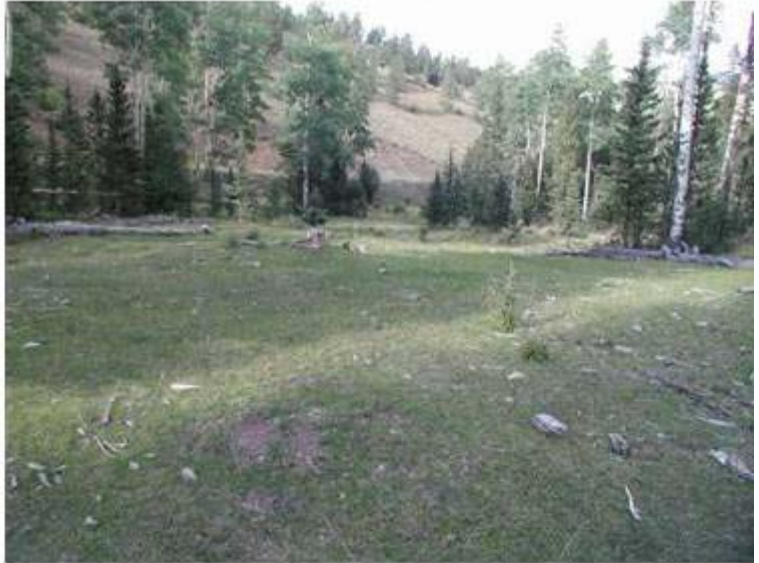
HPR #21 UTM 472290/40072756 Grazed

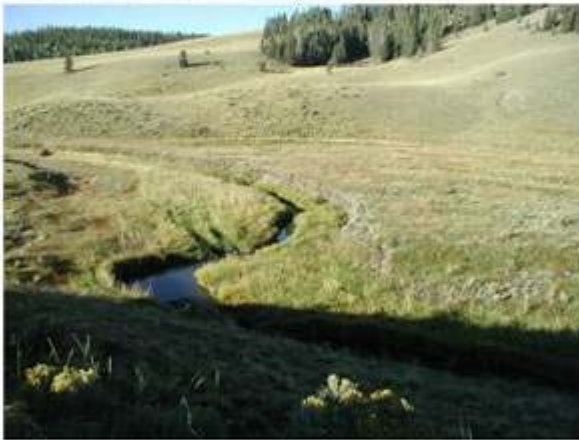
HP#22 Meander recovering on eroded banks

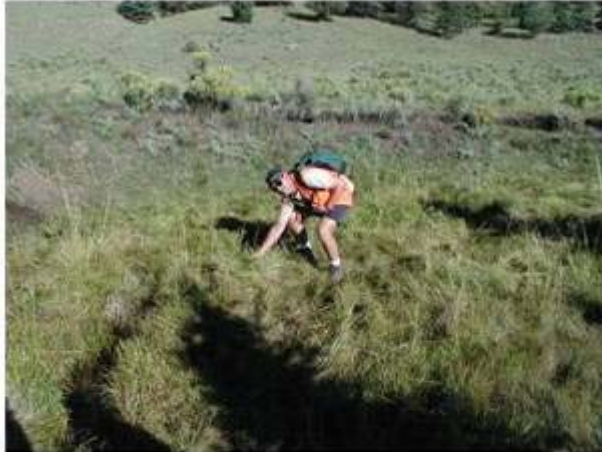
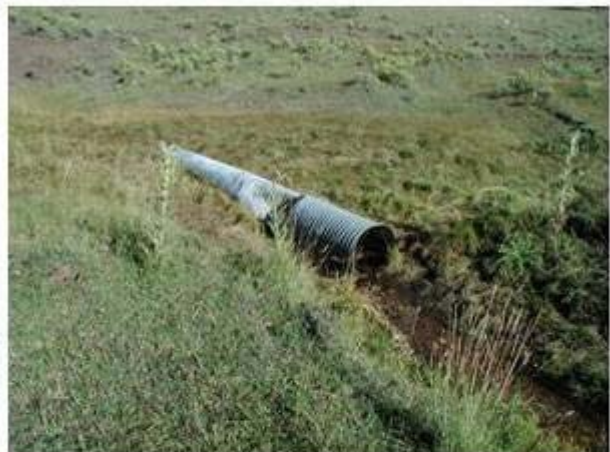
HPP#26 Little Costilla—gravel stream bottom, stable flood plane, healing eroded slopes, Kirk Gadzia showing grazing level. **HPP#27** UTM 47 4876/4073404—exposed culvert.

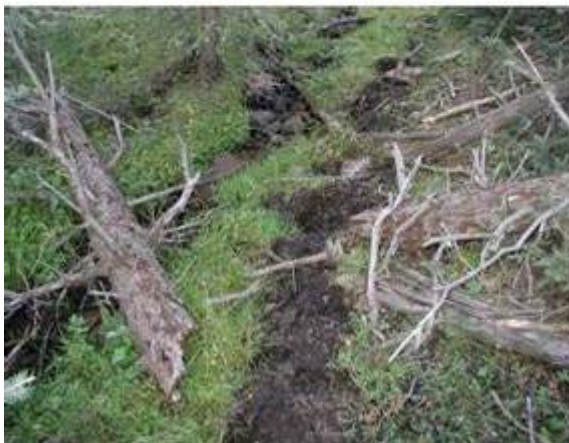
HPP #30 UTM 47 5189/4074332
Along creek/narrow/hammered by cattle

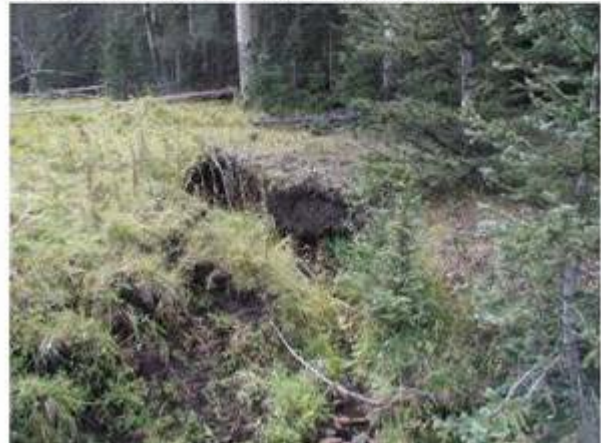
HPP#31 UTM 47 5358/4074390 head cut at spring bog could be lowering the water table in meadow

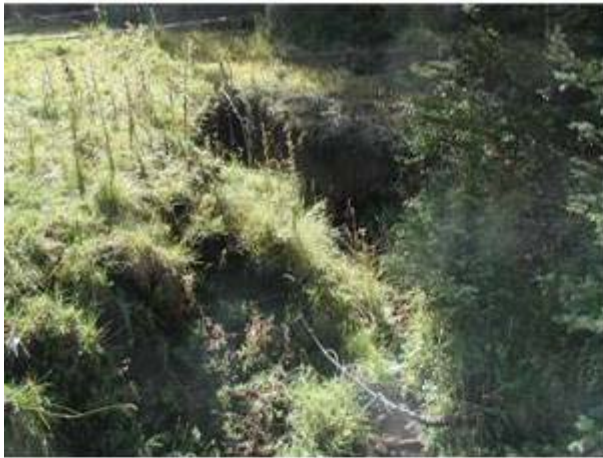
HPP#32 UTM 475358/4074390 head cut at spring bog could be lowering the water table in meadow

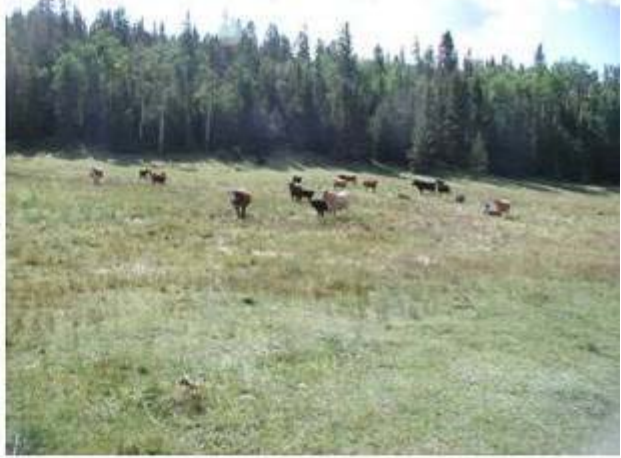
HPP #33 UTM 475554/407444 Upper meadow approximately 30 head parked; pasture grazed heavily probably move into canyon during hot part of the day

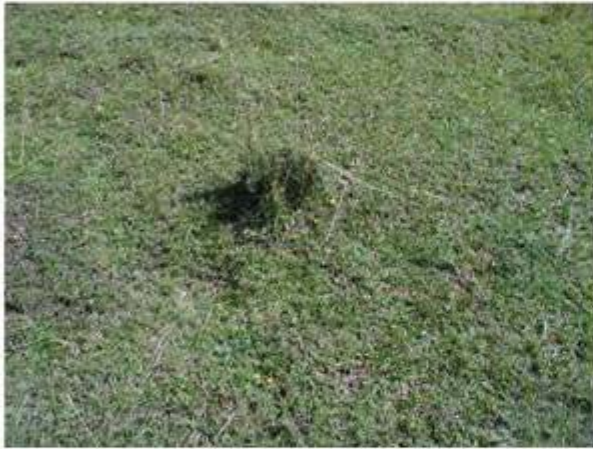
HPP #34 UTM 475554/407444 overgrazed plant with elk droppings

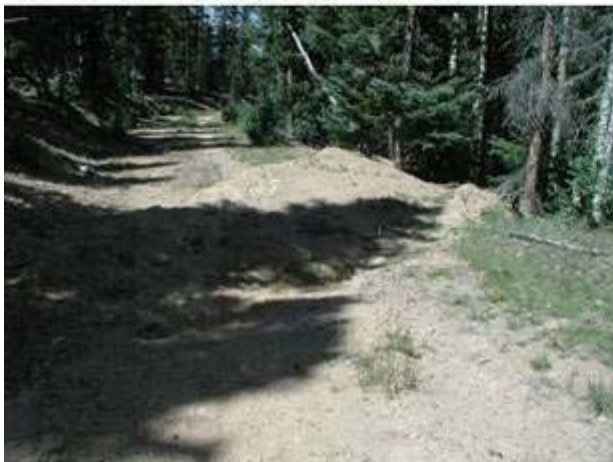
HPP #36 UTM 475353/4076437 water bar

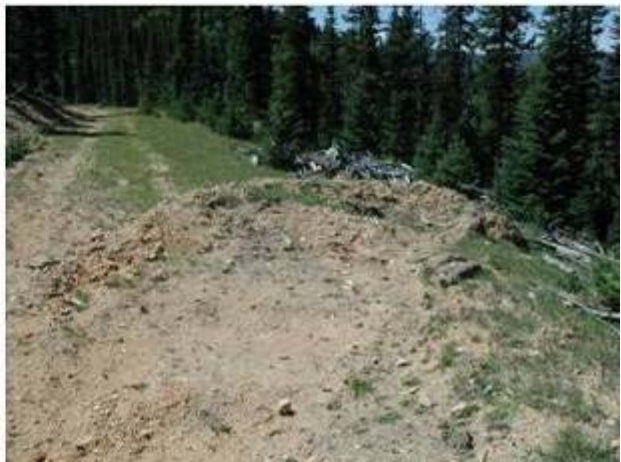
HPP #37 UTM 475453/4076581 water bar adding to erosion

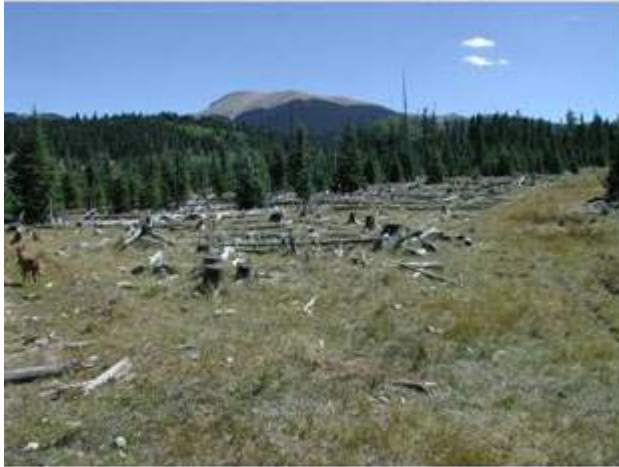
HPP #38 UTM 4762137/4076366 Heavily logged area.

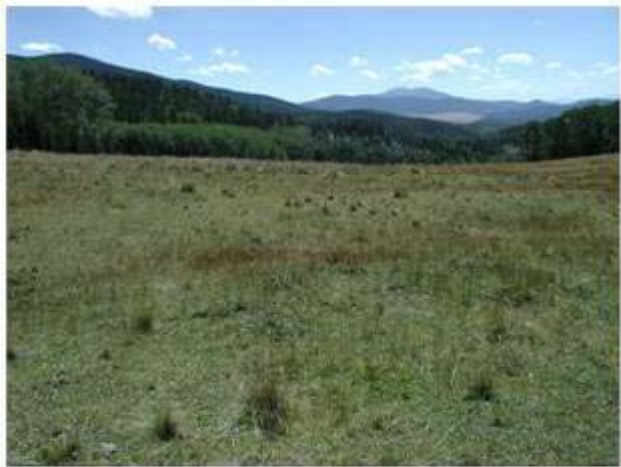
HPP #39 UTM 476639/4076234 Grazed area from livestock and elk.

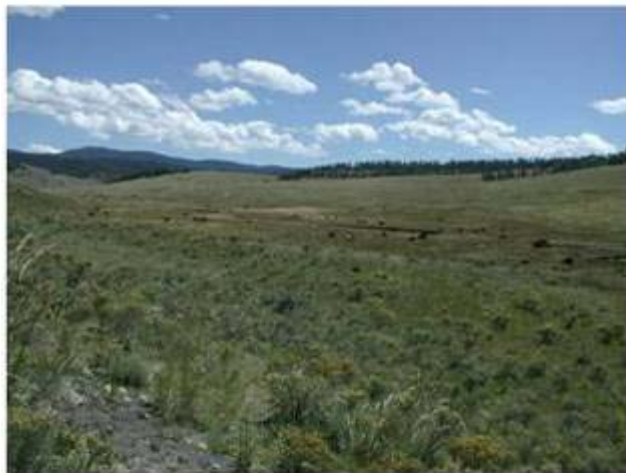
HPP#45 (MPP#4) UTM 0475423/4070350 9250 Ft. 245 degrees WSW looking across creek bank cut with trees

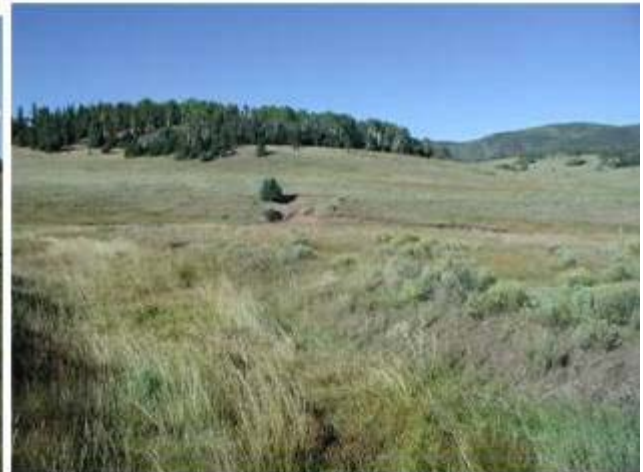
HPP#46 (MPP#5) UTM 476129/4069641 eroded bank Canada thistle browsed along trail UTM 76465/4069833 Small spruce trees growing in creek; Zeedyk erosion controls needed on road along creek/big and small side cuts

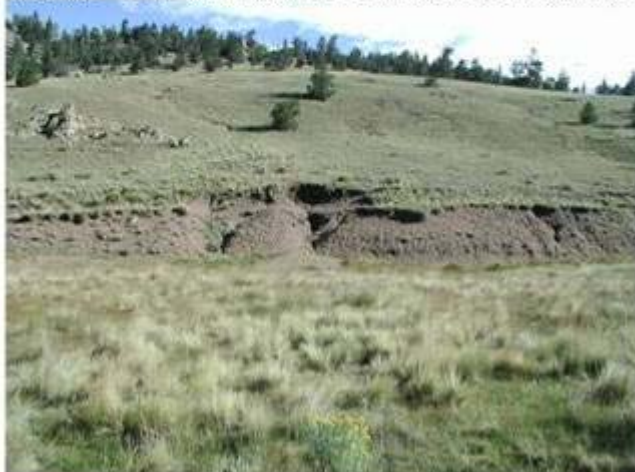
HPP#47 UTM 476732/4069950 Channel cuts on grazing area

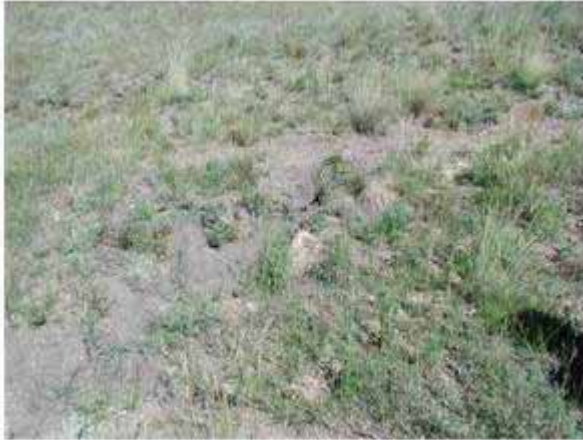
HPP#48 mini erosion point

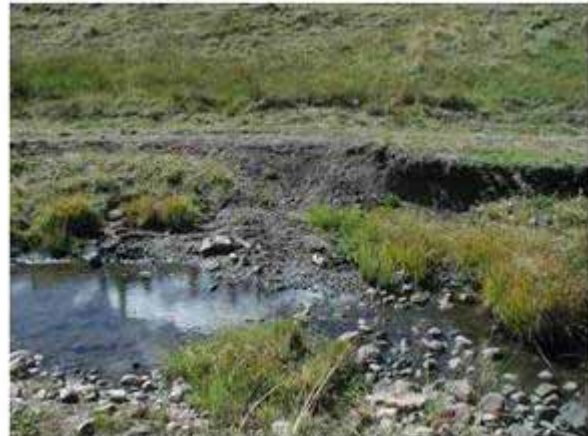
HPP#51 UTM 476874/4067861 Cattle drinking spot with water moderately turbid

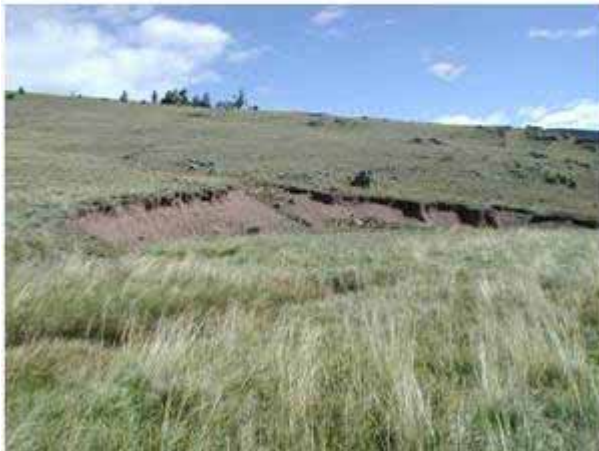
HPP#52 UTM 477052/4067901 Erosion cut on Vidal Creek

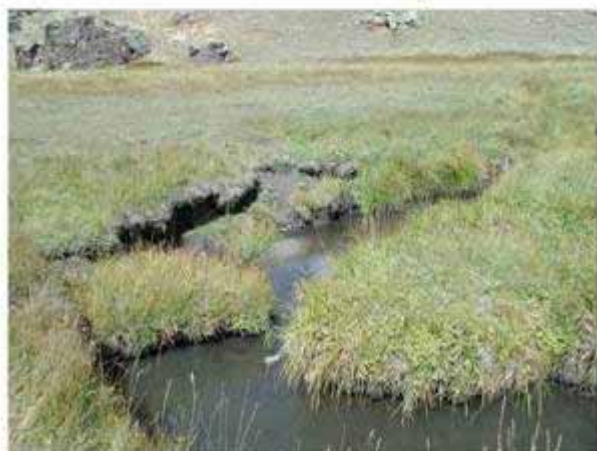
HPP#53 UTM 477307/4067914 Cutting on Vidal Creek

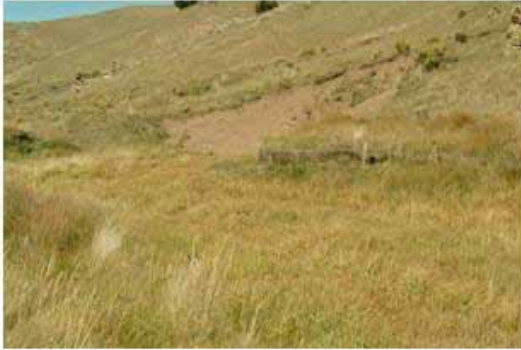
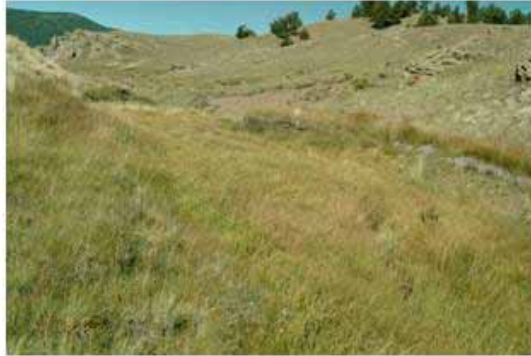
HPP# 55-56 UTM 0475723/4069308 9300 ft. La Belle exit, amount of soil loss contributing factors, 4 to 6 feet depth of soil loss, note slope failure

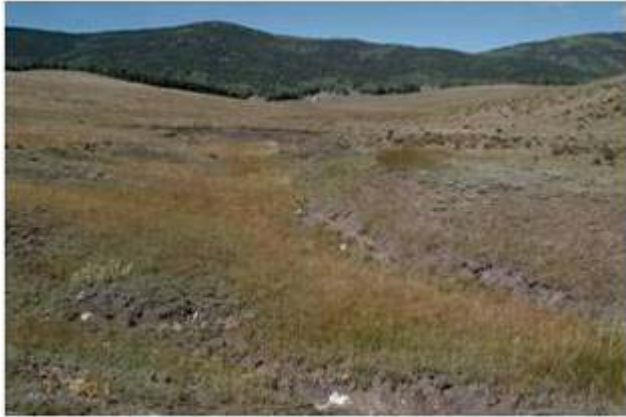
HPP#60 at split to lodge 5-6 ft cut healing

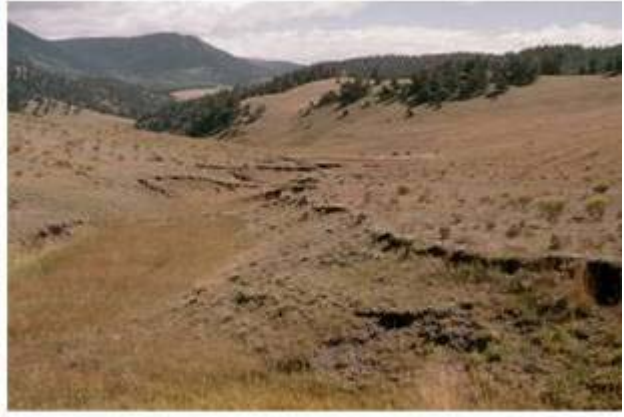
HPP#61 at split down La Belle, cutting evidence, mostly healing

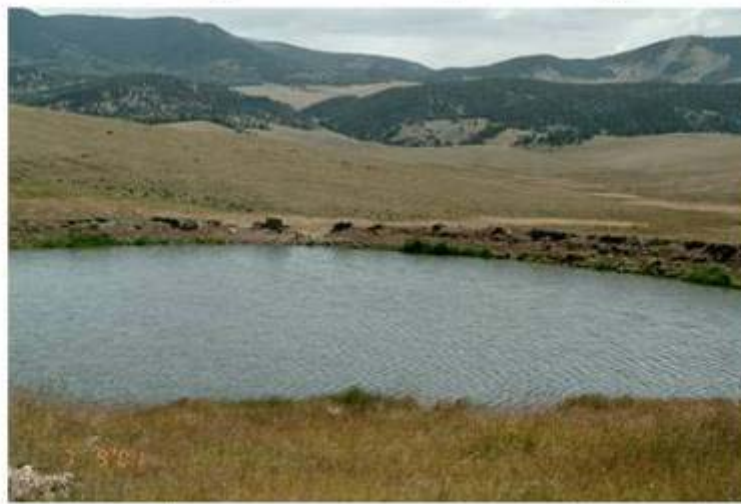
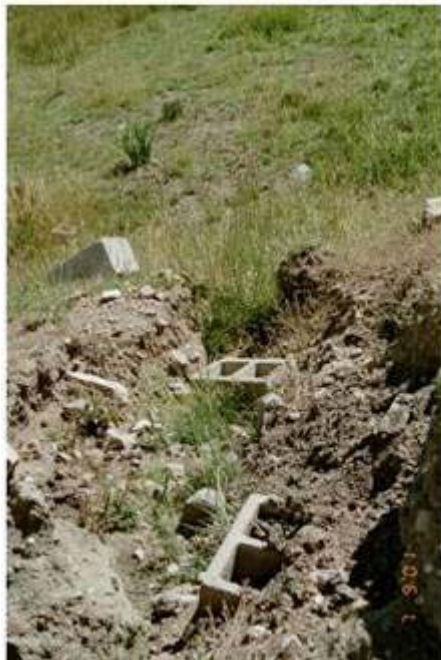
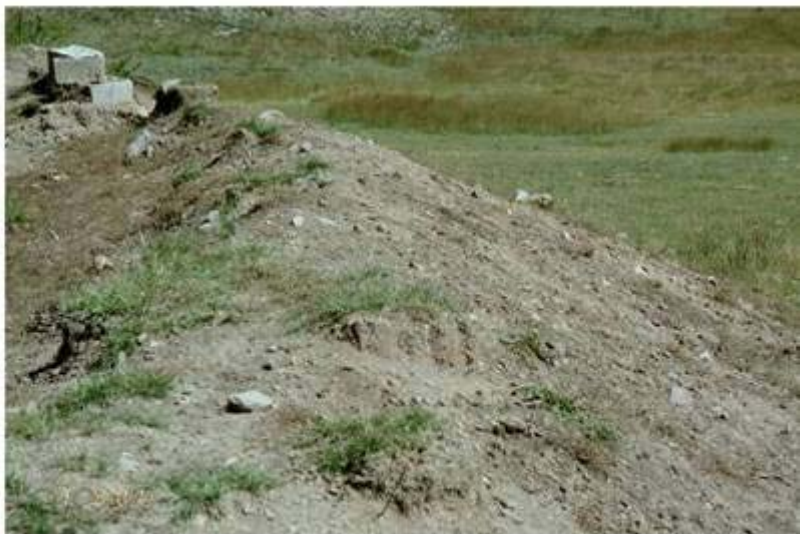
HPP#62 UTM 0473268/4068408 La Belle Lodge—earth dam in danger of breaching, cut lower than spillway—view NE 50 degrees

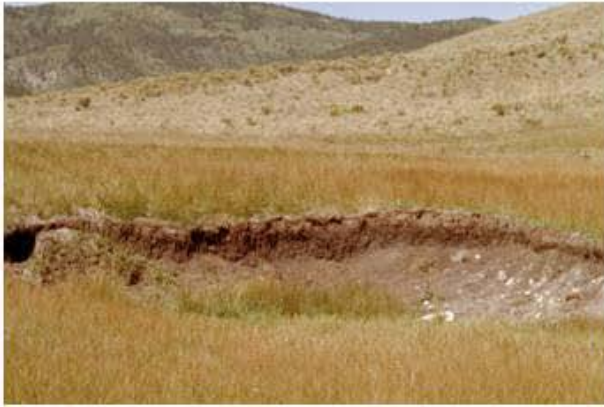
HPP#63 La Belle Creek North Fork, extreme soil loss and head cutting:

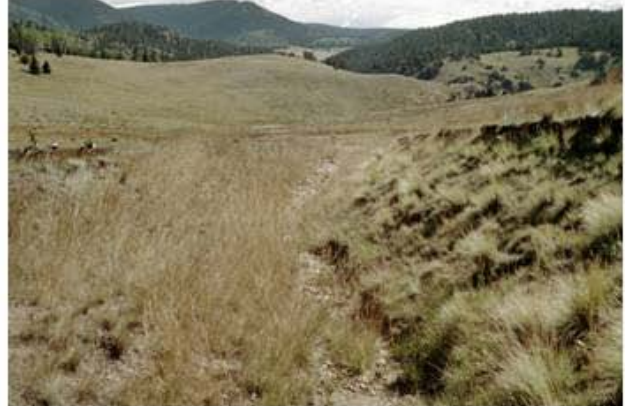
HPP#64 La Belle North Fork Right: where left fork of the north fork come together, 200 yards up from main fork, significant head cuts 3 to 4 feet drops in stair step forma-

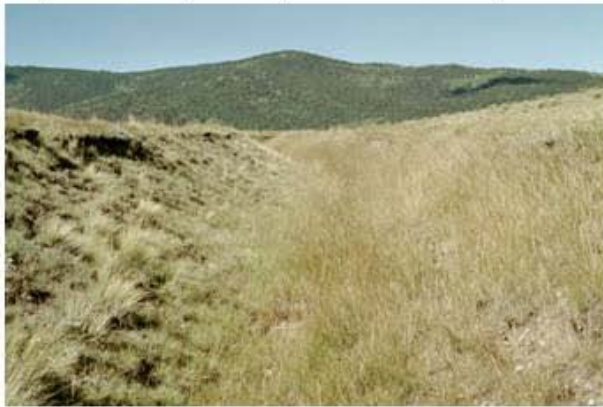
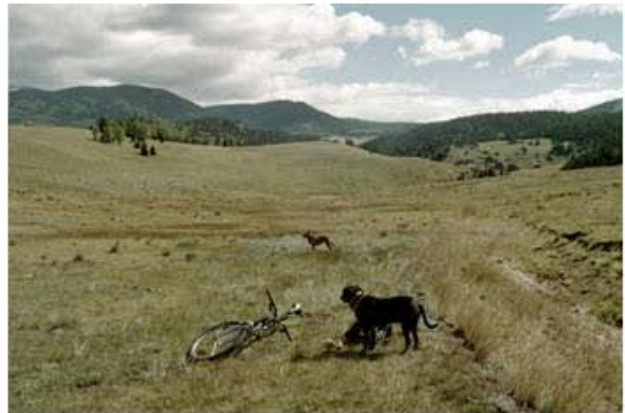
HPP#65-66 Left fork of the north fork of La Belle: #65 road cut, grass over but bottom showing gravel and soil movement, drops into drainage with major head cuts, #66 up hill from bottom of road.

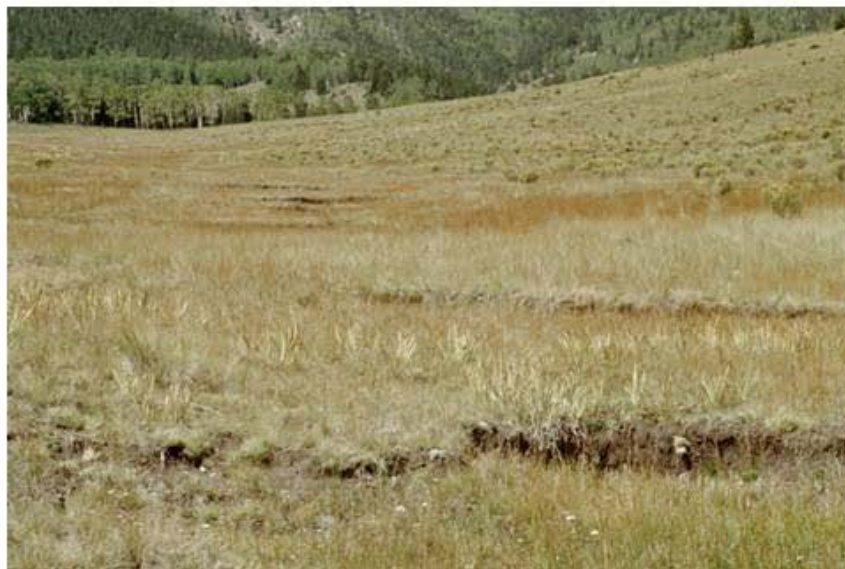
HPP#67 Stock pond, right side of north fork, silted in with very little water and washing out, soil movement with stair step head cuts 8 inches to 2 feet.

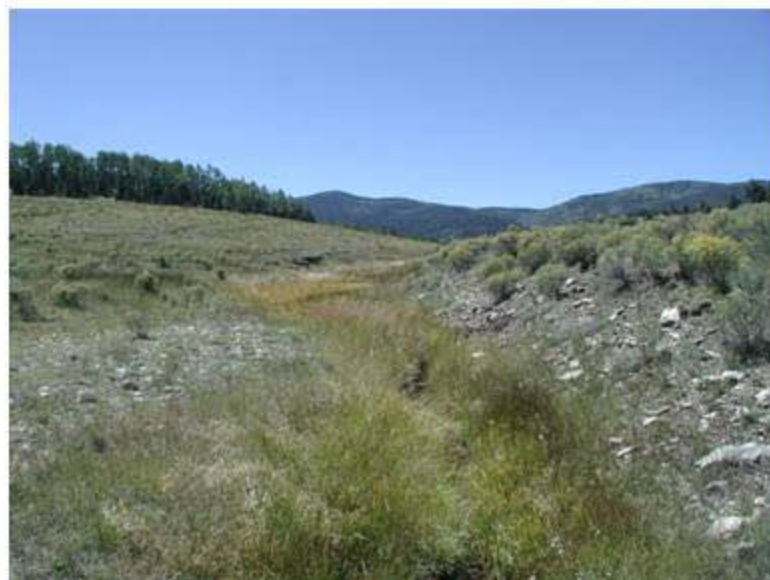
HPP#72 Base of Gold Creek showing channel in recovery.

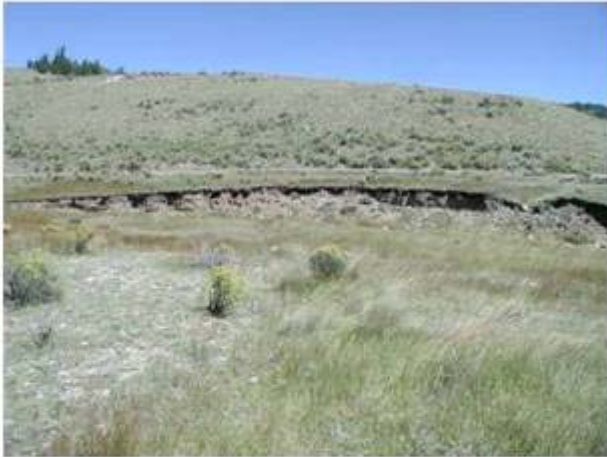
HPP#73 UTM 479276/4070451 Bank erosion on Comanche Creek

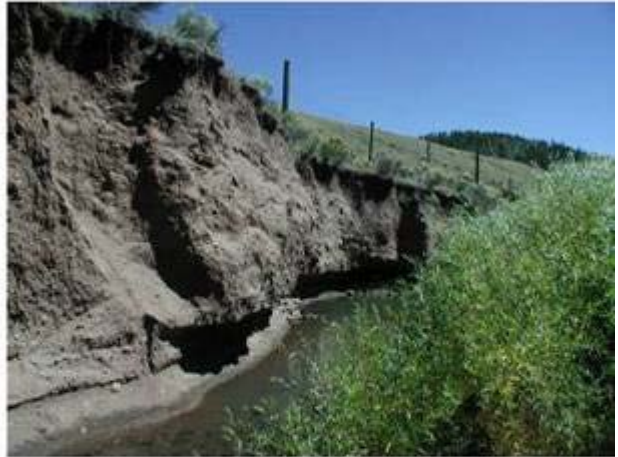
HPP#74 UTM 475232/4070583 Bank erosion point inside enclosure

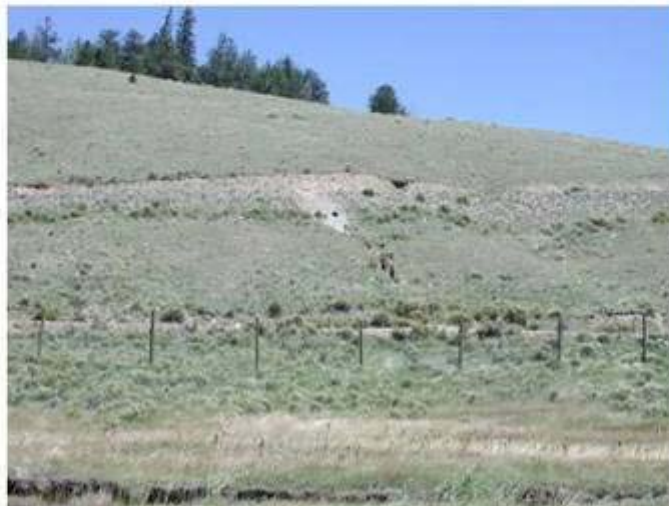
HPP#77 Culvert damage from enclosure

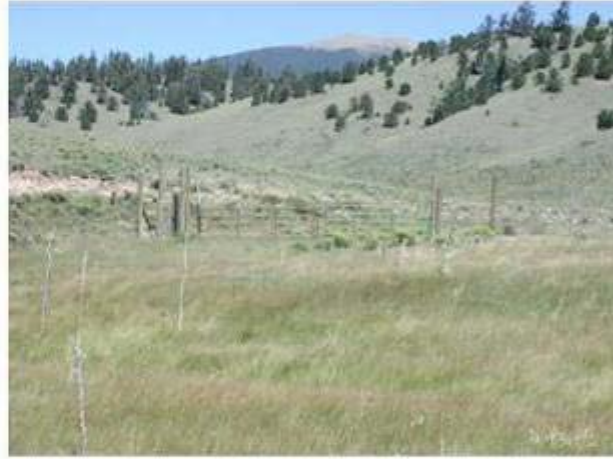
- The large livestock and elk enclosure has not been effective for elk. The gate into the enclosure is of standard height. Aspen regeneration on the upper portions of the enclosure was dramatic compared to the area outside the fence, but little difference in herbaceous cover was noted. Willow regeneration was also noted in the enclosure.

HPP#81 Gate into ex-closure is to low! 4 feet high Elk can easily cross into ex-closure area; there are lots of elk droppings

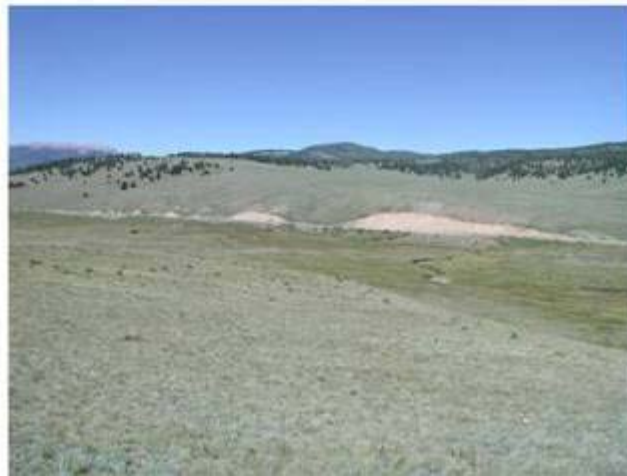
- The main road cut from the confluence of Costilla and Comanche creek upwards to the confluence of Gold creek and the gated road previously described appeared to be a major contributor of sedimentation to the creek. New construction including culverts, fill material, water holding areas, water bars and other activities associated with the road were observed. Nowhere along any of the drainages and upland areas we visited was there such a large amount of exposed soil as the road areas being described here.

HPP#82
Road cuts on
Comanche Creek.

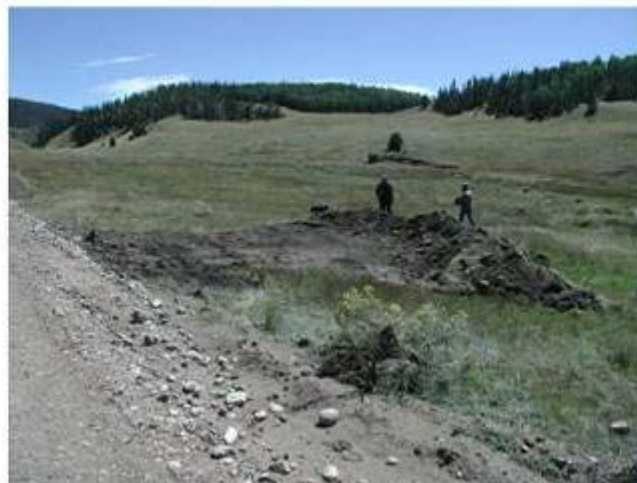
HPP #87
Recent culvert and holding
pond installation
contributing to sediment
