# **Comanche Creek Trout Habitat Monitoring DRAFT Summary Report for 2001-2004 Data**

**By Art Vollmer**  
**Truchas Chapter of Trout Unlimited**

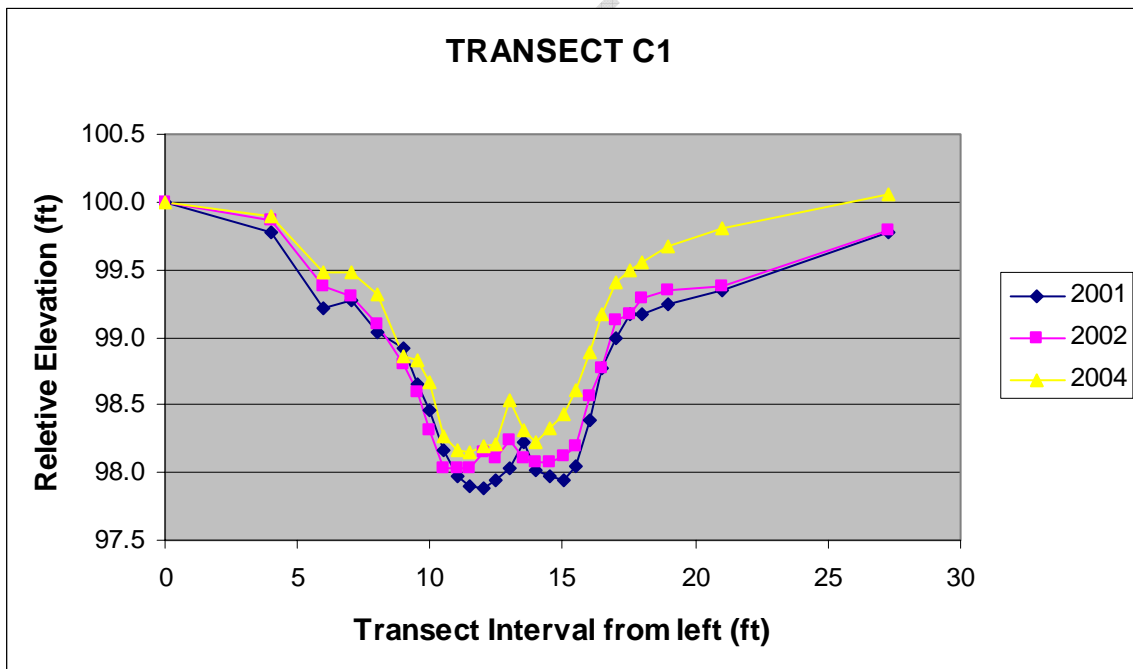
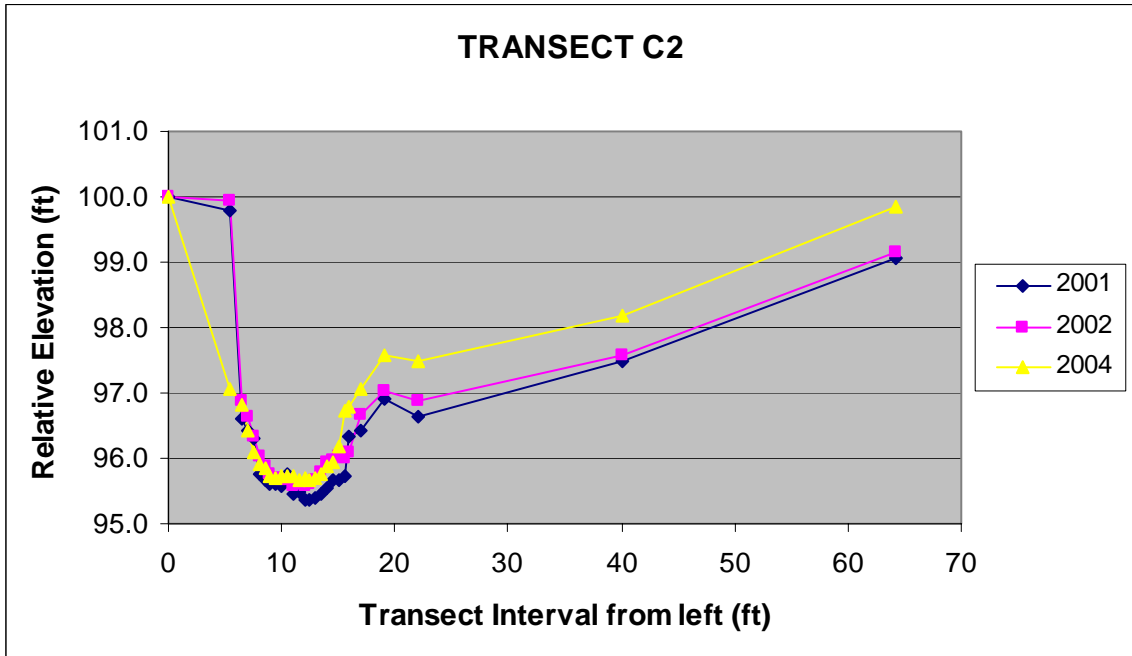
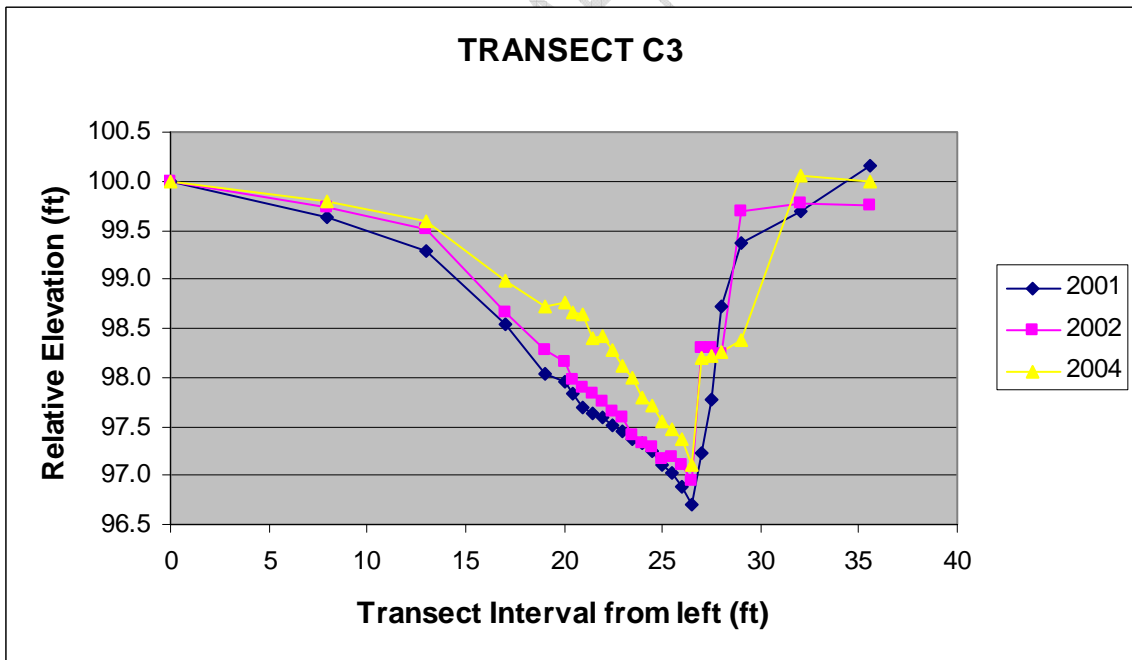
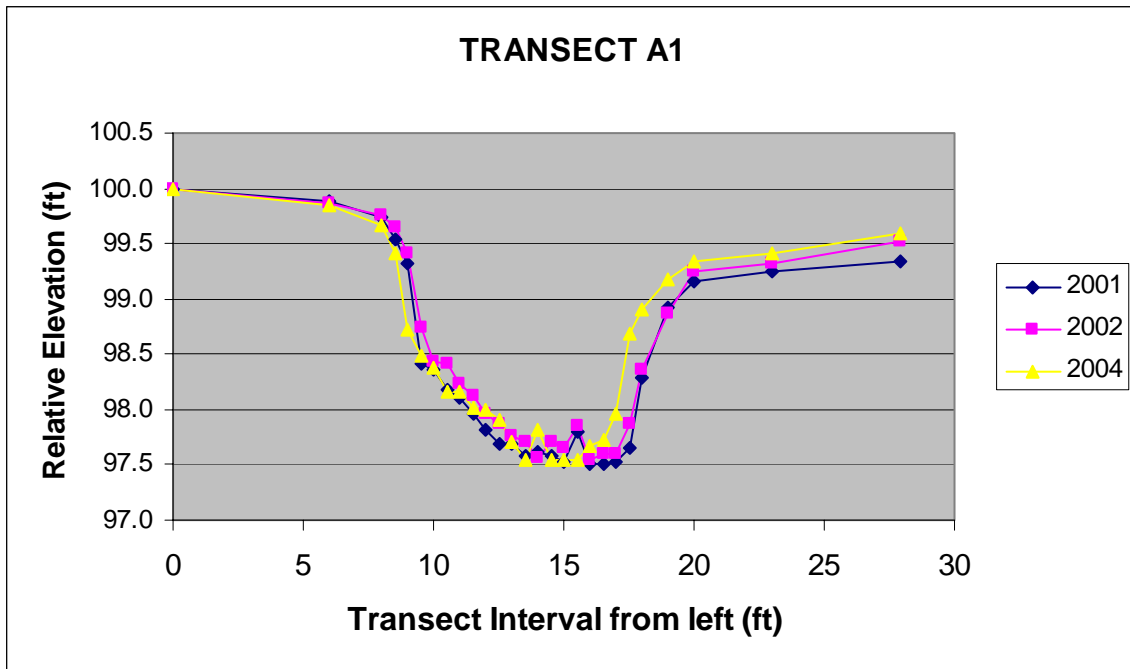
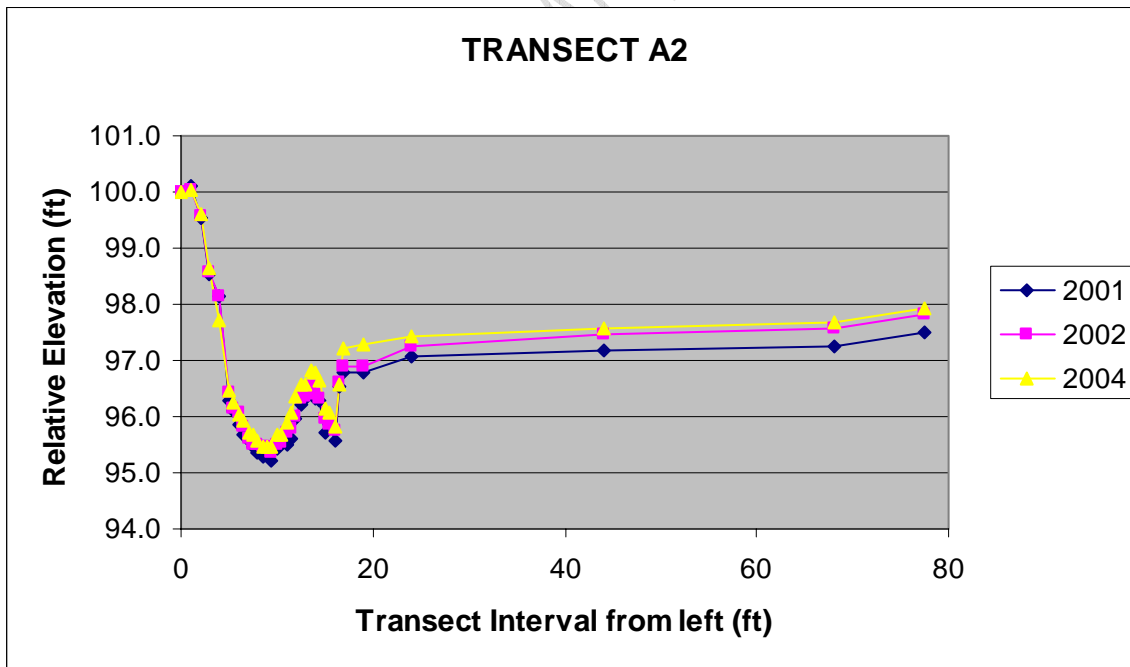
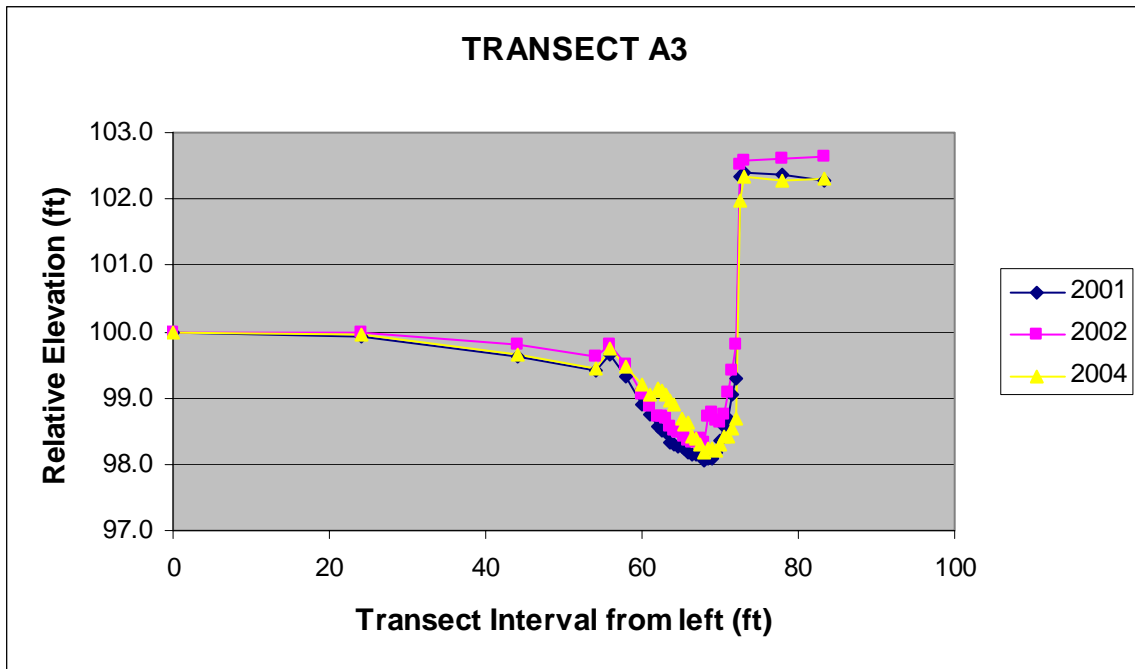
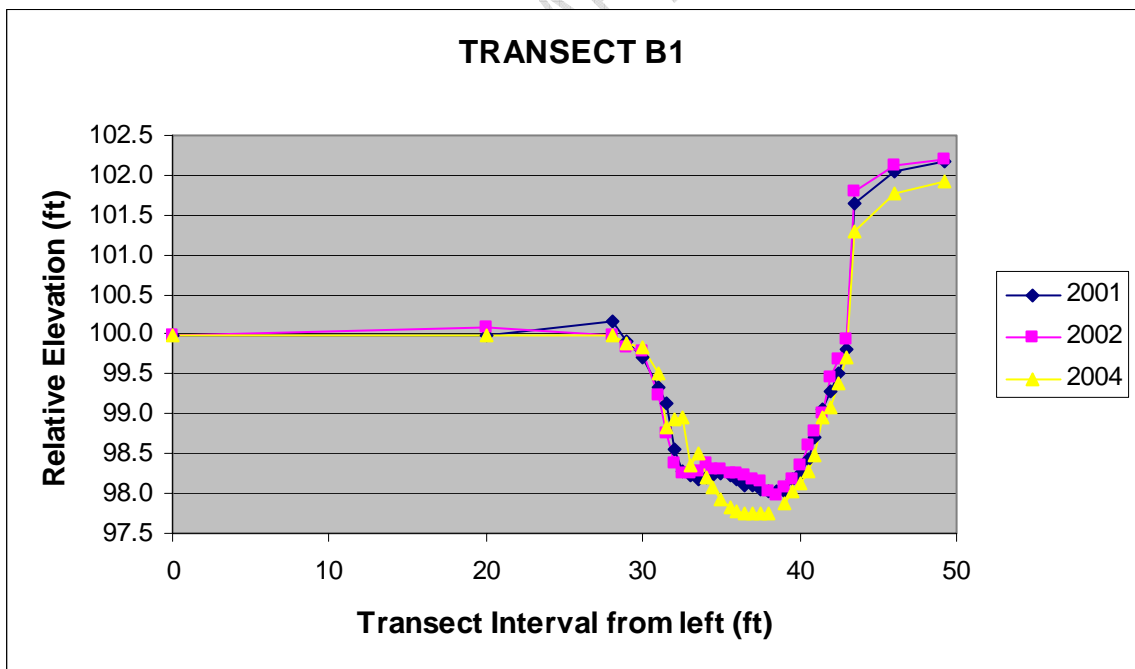
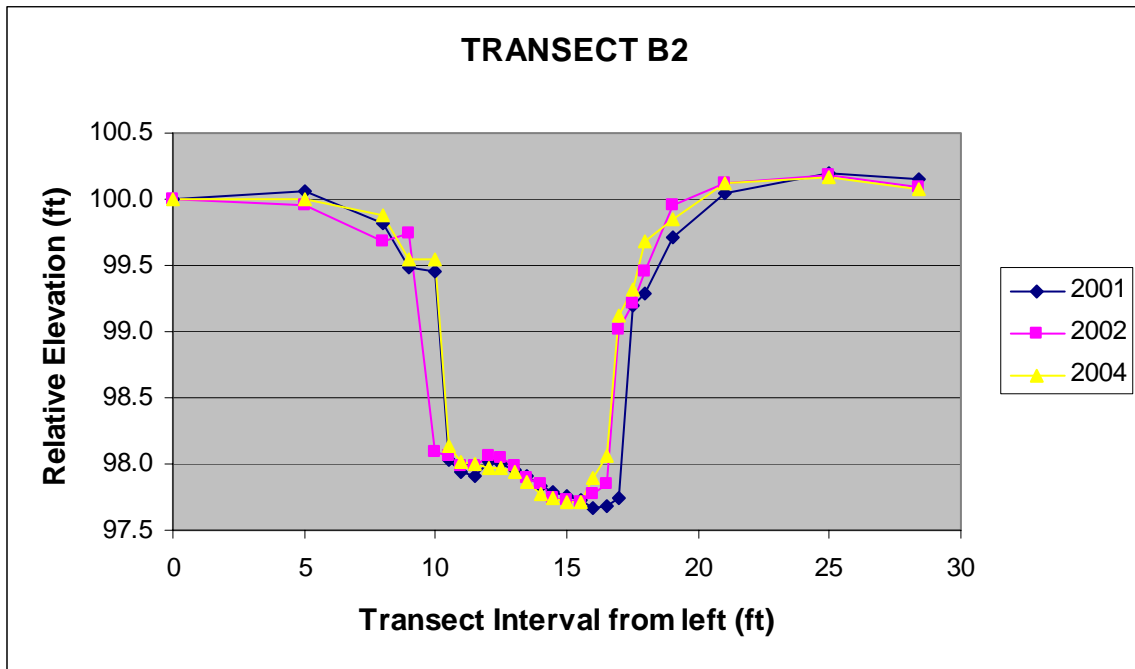
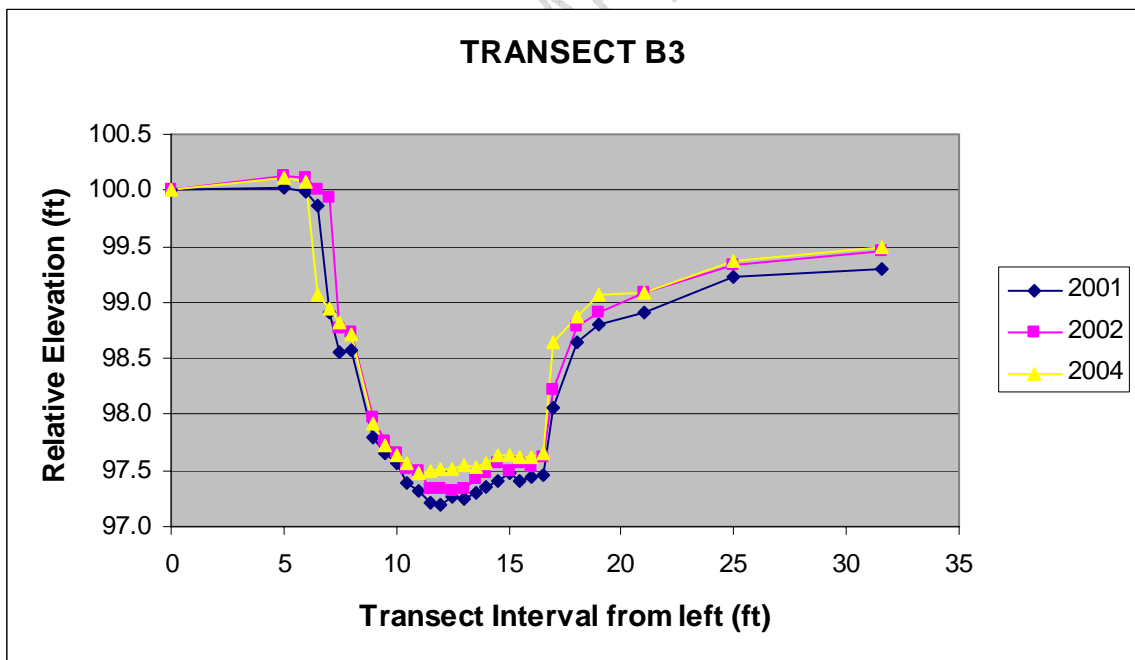
The control site appears to show some significant sloughing of the steep, raw cutbanks in cross sections C2 (left bank) and C3 (right bank). Cross sections B3 and A3 show bank sloughing to a lesser degree. Cross sections B1 and C3 show significant channel narrowing and possibly the beginning of a new bankfull bench on the right for C3. Cross section B1 also appears to have deepened significantly. While there is some apparent accretion in cross sections C1 and C2, this may be measurement error due to problems associated with maintaining a level measurement line. This would explain why the right endpoints for 2004 are several inches higher than previous years. It is unlikely these endpoints could have received significant sediment deposits during the low flows of recent drought years.

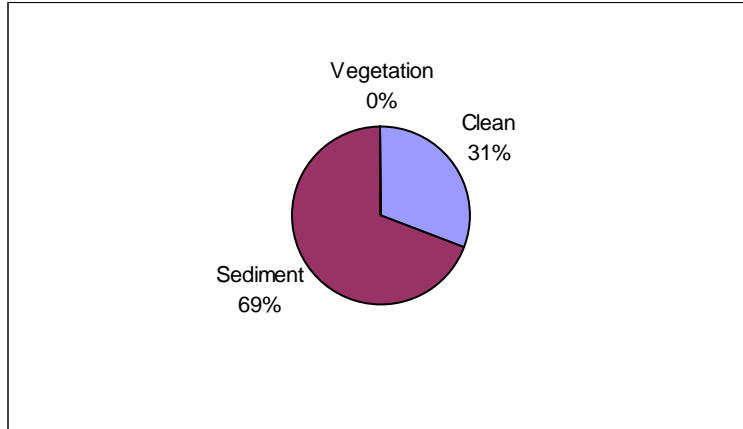
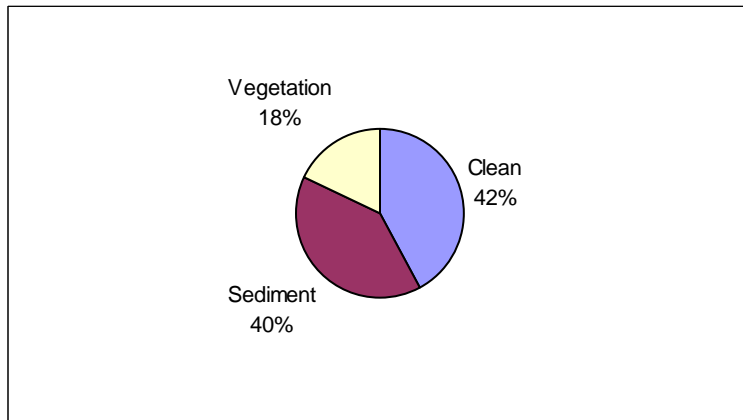
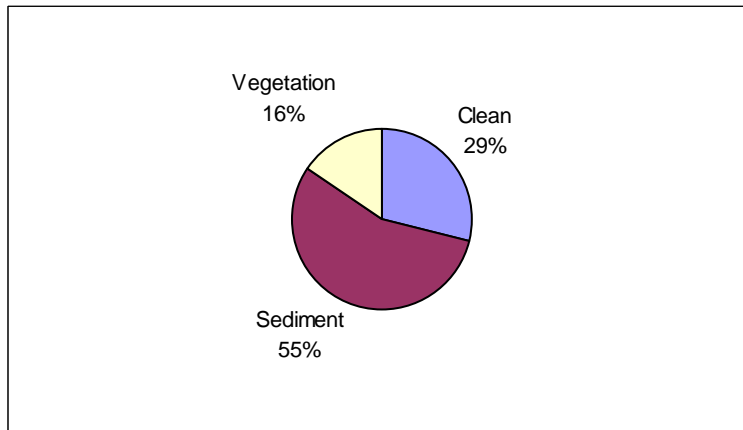
### Combined Substrate Data for All 'C' Transects

Unlike the bank pin measurements, the stream bottom substrate a somewhat consist trend across most locations. While none of the six stream bottom transects showed any vegetation in 2001, five transects had at least one data point with vegetation by 2004. This is most apparent when all data are combined for a particular reach of stream. This seems to indicate that the edges of the stream bottom are being colonized by plants, which could aid in bank stabilization. Changes in the percentage of clean- versus sediment-covered points did not showed any particular trend.
