Comanche Creek Watershed Restoration Project:  
Restoring Habitat for the Rio Grande Cutthroat Trout, Part 2  
October 2007 Report

(August - September 2007)

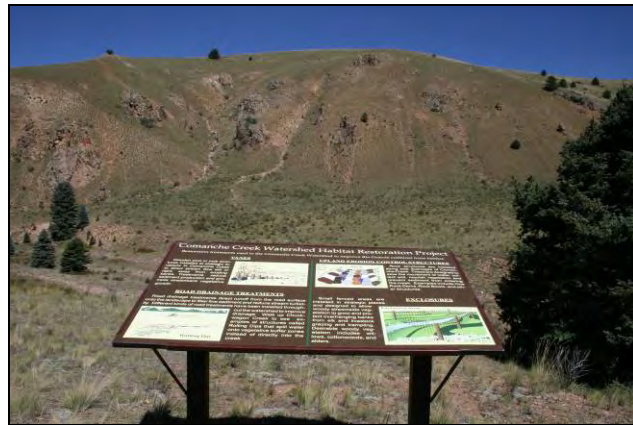
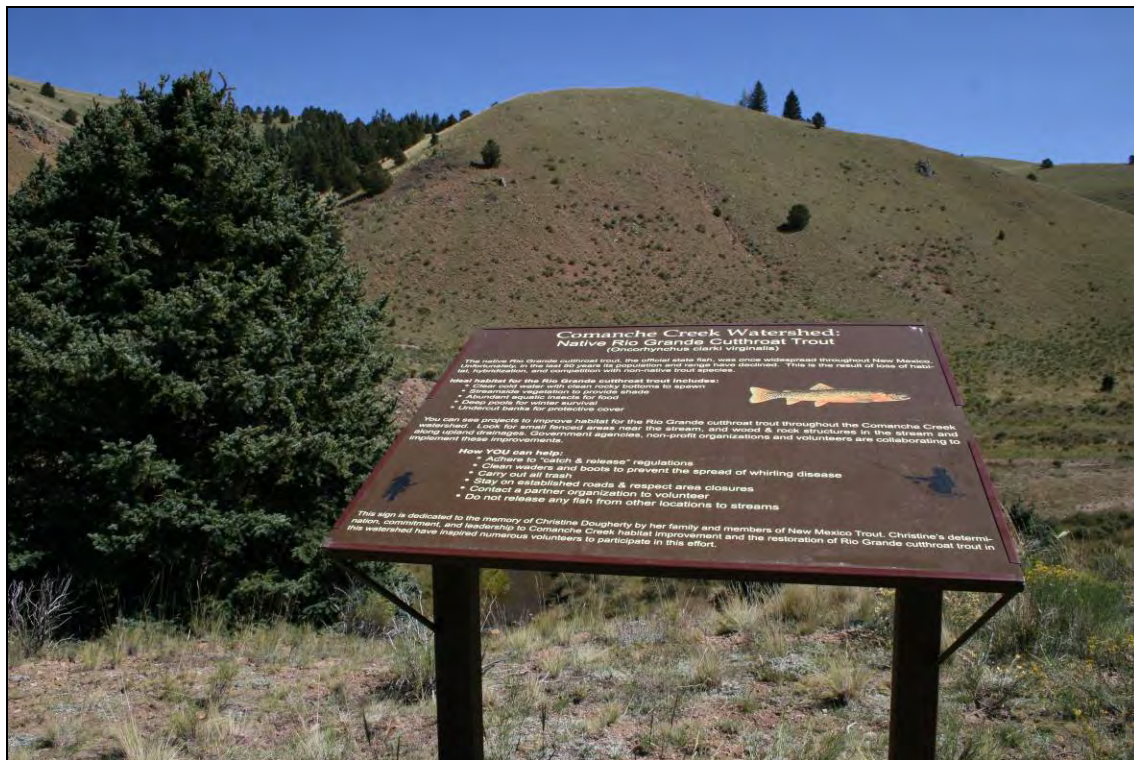
The Comanche Creek Educational Signs at the confluence of Costilla Creek and Comanche Creek and at the Chuckwagon parking area were re-created and then installed during the July 2007 workshop.

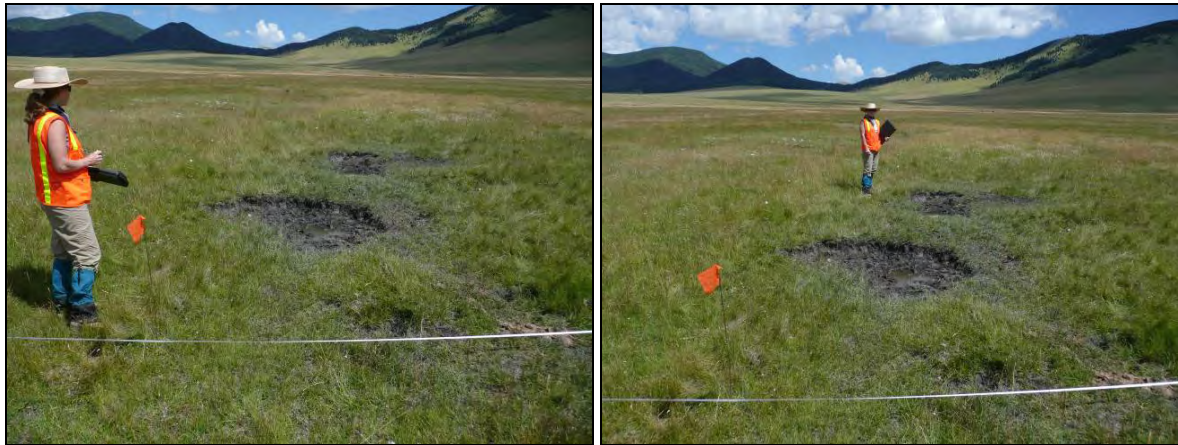
Vidal Creek has and continues to be incised but it does not appear to have changed much over the past six years. The wet meadow at the top of this drainage shows signs of less hummocking and expansion of wetland species. This may be due to the herding capabilities of the cattle themselves. A black bull did an amazing job of rounding up the cows, calves and heifers and moving them out of the Vidal Creek wet meadow and into the grasslands of the Valle Vidal. According to the 2007 AOI cattle were not due to be in this pasture until October 2<sup>nd</sup>, 2007 i.e., they were a month early! On transect line #2, a developing headcut was observed between the 42 and 45 meter mark (photos # P1010450 and P1010451).

Developing headcuts at the top of Vidal Creek.

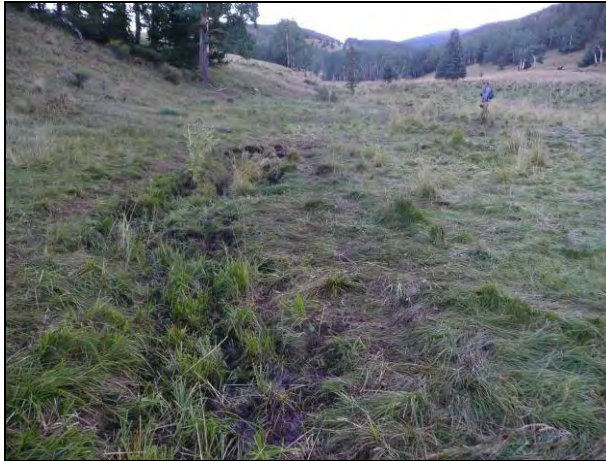
During the 2004 Monitoring, this wet meadow showed channelization through the upper reach of the wet meadow and heavy utilization by cattle. In spite of having previously identified these areas as sensitive, conditions have certainly not improved and have actually deteriorated as shown in the photos below.

Heavy trampling in Springwagon Creek.

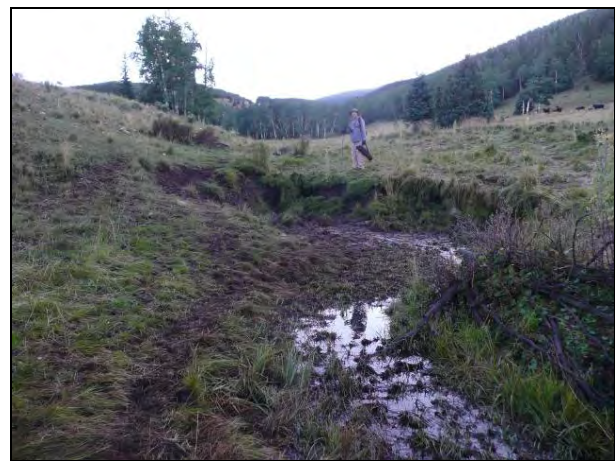
Headcut at the top of Springwagon Creek.

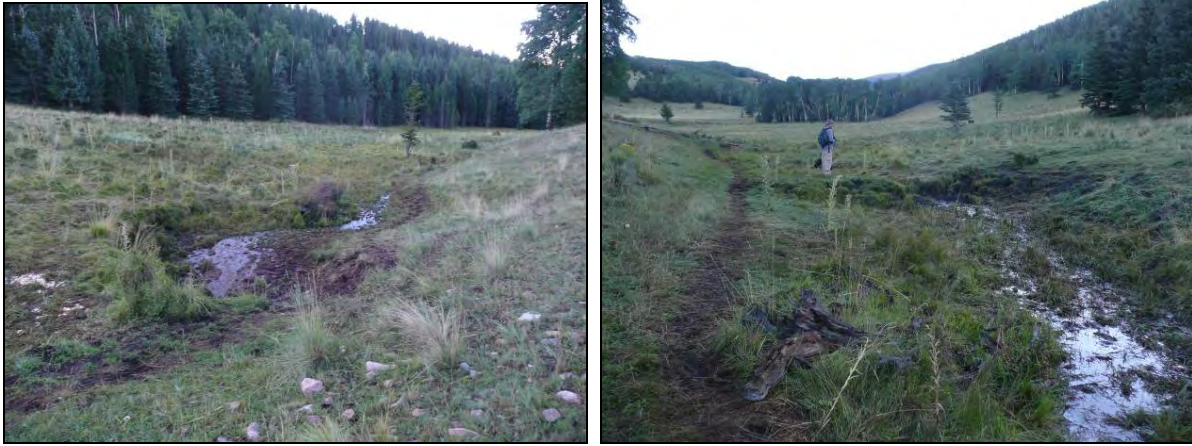
Signs of recent heavy livestock use in Springwagon Creek.

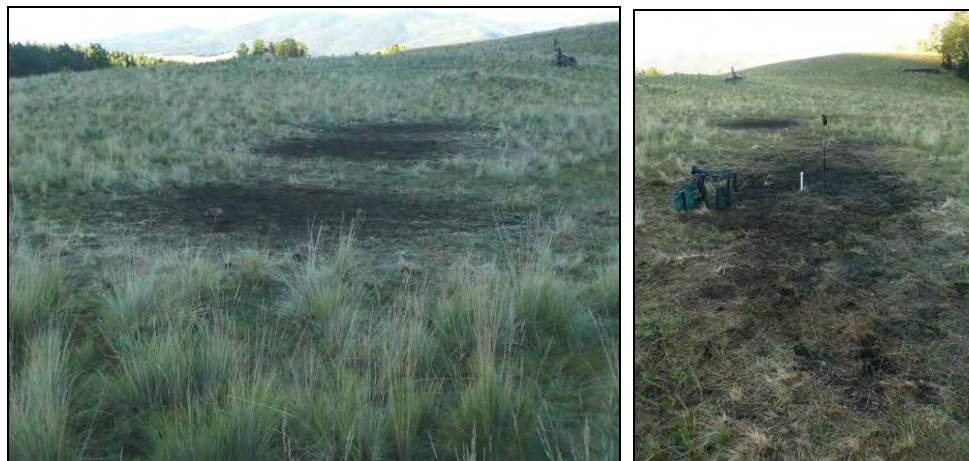
Salt block locations in Springwagon Creek drainage.

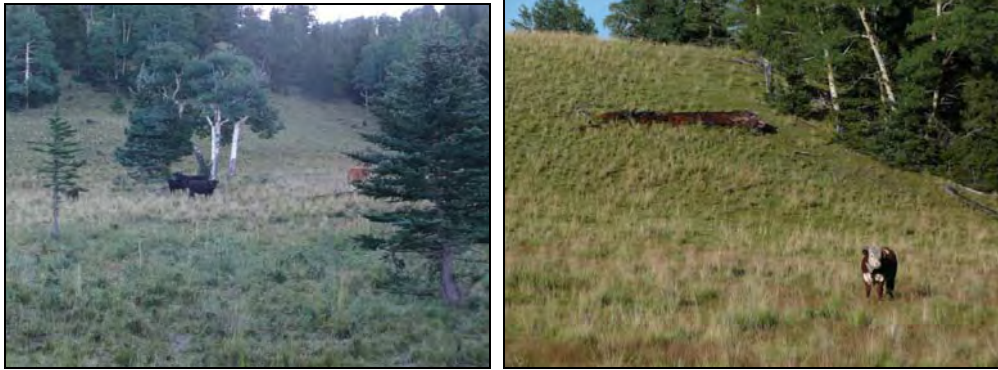
Cattle were scattered throughout the area and one roaming bull (photos P1010494 and 500).

Cattle observed in Springwagon

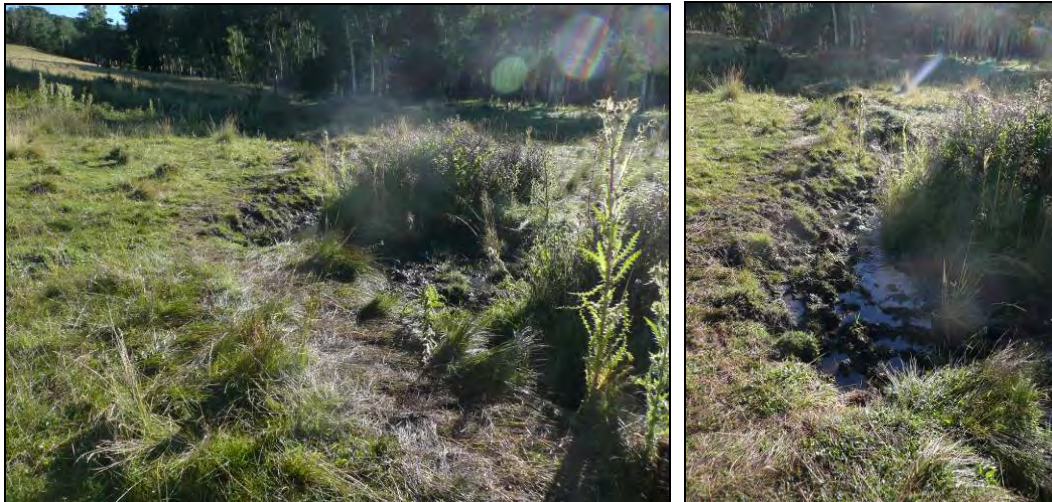
The headcuts extend up to the large area of aspens (photos P1010502 and P1010503).

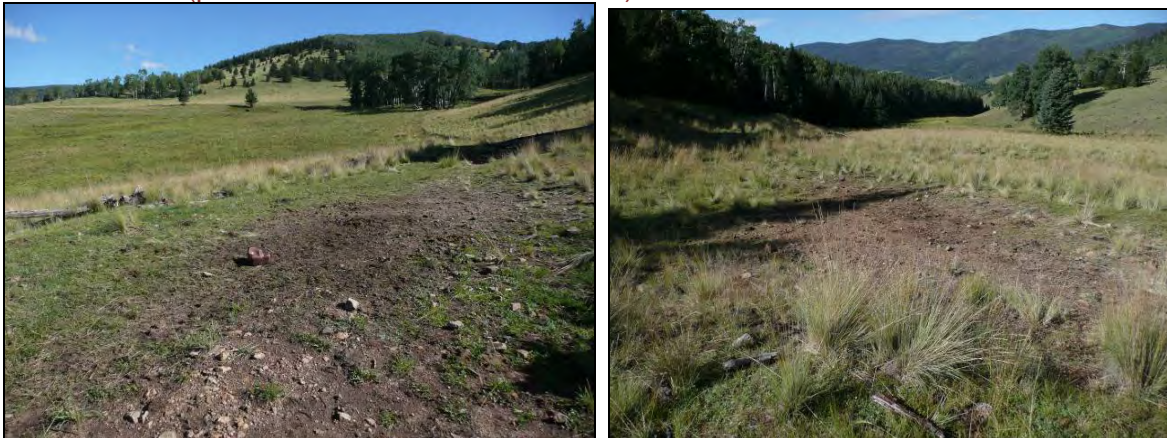
As we hiked down the meadow following the abandoned road we saw the remains of 2 more salt blocks (photos P1010507 and P1010508).

Additional salt block locations in Springwagon.

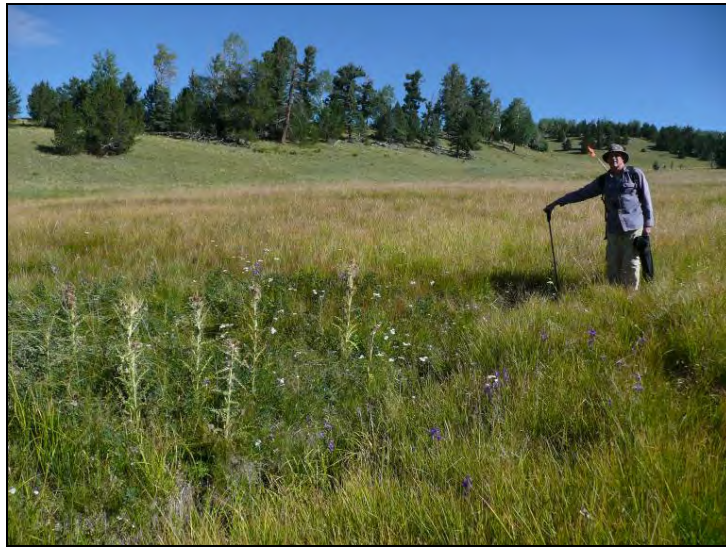
We headed back up the hill and over the ridge ending at a pasture gate. We crossed back down through Holman creek and observed a ~2 foot headcut. The area did not show heavy utilization, but cattle were in the vicinity. The area is well vegetated, so it wasn't evident if

the headcut was migrating, but there was a “waterfall” sound. This headcut is easily accessible from FS Road 1950 and could benefit from a headcut control treatment.

Headcut in Holman Creek

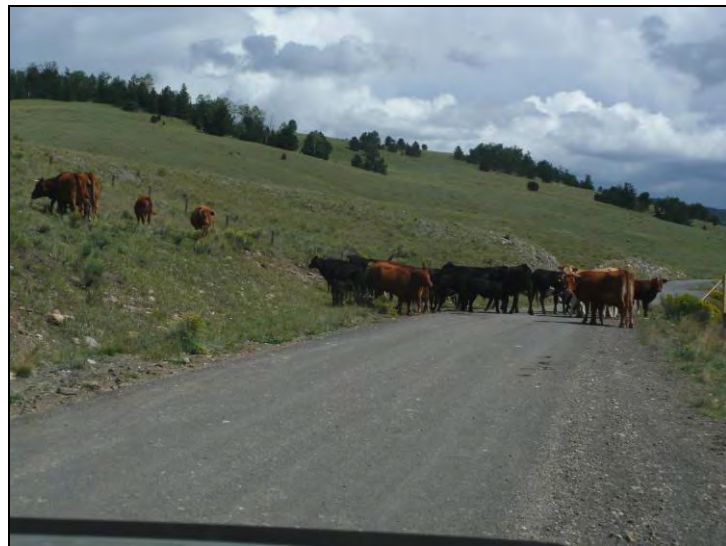
At 10:45 am we arrived back at the La Belle Parking area and watched the Range Rider move about 20 head of cattle off the uplands near the intersection of 1950 and the La Belle FS road down to the cattle guard at Little Costilla (P1010524).

Cattle being moved in La Belle

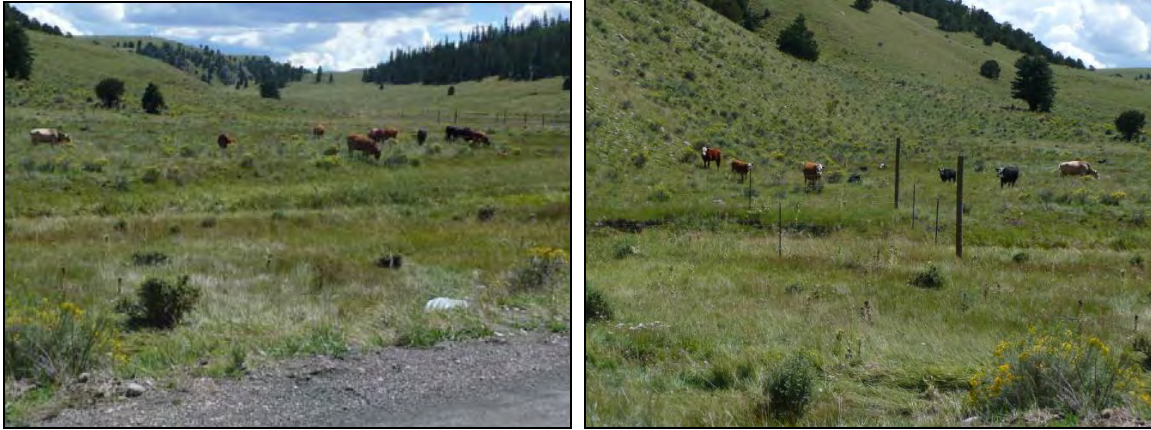
In the afternoon we headed back up to just west of the Chuckwagon Creek parking area where we noticed cattle at several locations along Comanche Creek, including at the confluence of Fernandez Canyon (photo P1010519 and P1010520).

Cattle along Comanche Creek and confluence of Comanche and Fernandez Canyon
