1. Project Titles: Multi-Basin Riverine Restoration in New Mexico: Comanche and Gold Creek

2. Project Applicant: The Quivira Coalition, 1413 2nd St., Suite #1, Santa Fe, NM 87505; phone: 505-820-2544, fax 505-955-8922; mbain@quiviracoalition.org. The Quivira Coalition is a Santa Fe non-profit organization whose mission is to foster ecological, economic and social health on western landscapes through education, innovation, collaboration, restoration and progressive public and private land stewardship. The Quivira Coalition has and is currently implementing EPA 319(h) Water Quality and EPA Wetland projects in watersheds throughout New Mexico.

3. Project Areas: In the **Upper Rio Grande Basin**, treatments will be implemented on Comanche Creek and its tributary, Gold Creek, located within the Valle Vidal Unit of Carson National Forest of north central New Mexico, Taos County (Appendix A, Map A). Comanche Creek is a tributary to Rio Costilla within the Upper Rio Grande watershed (USGS Hydrologic Unit Code 13020101015) and contributes 27,430 acres or 43 square miles to the Costilla Watershed (Pittenger 2002). The headwaters of Comanche Creek lie at an elevation of roughly 10,400 feet.

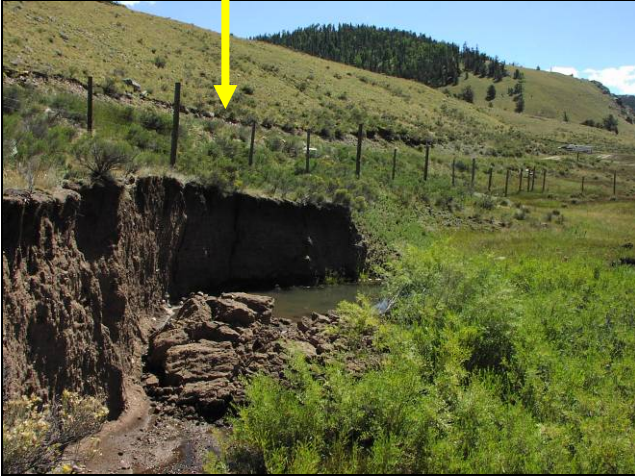
Photo #1

FS Road

For Comanche Creek there is an immediate need to stop the input of 110 to 120 cubic yards annually of sediment into waters that support habitat for the RGCT and stabilize the eroding bank that is encroaching on a Forest Service Road as per Task 4-C (Appendix B, photos #1 and #2).
