Comanche Creek Assessment Report

Presented by: The Quivira Coalition

For: The Environmental Protection Agency and the New Mexico Environment Department – Soil Water Quality Bureau

Grant Title: Comanche and Cordova Creeks Watershed Restoration Action Strategy, Education and Restoration Project, Project Number C9-996101-009-01; Contract Control # 02 667 5000 0007

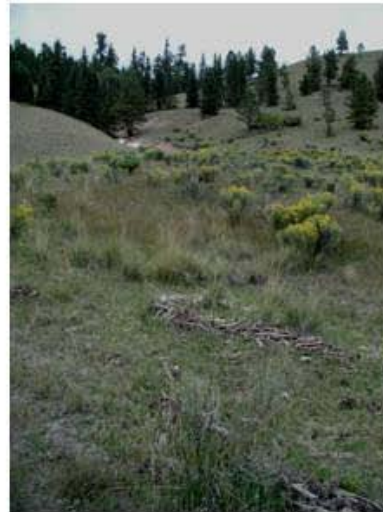
HPR#10
UTM
471817/4074027
Deposition, does sediment come from side cut?

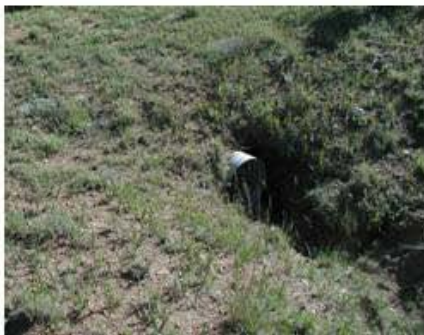
HPR #17-19 UTM 4728773/4073025 culvert/erosion

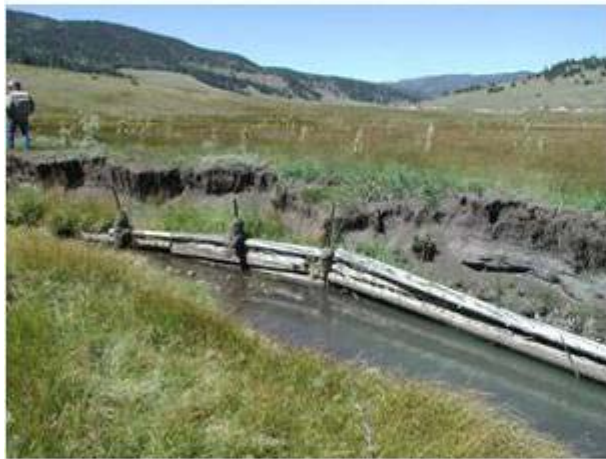
HPP#80 bank erosions stabilization structure
