Comanche Creek Assessment Report

Presented by: The Quivira Coalition

For: The Environmental Protection Agency and the New Mexico Environment Department – Soil Water Quality Bureau

Grant Title: Comanche and Cordova Creeks Watershed Restoration Action Strategy, Education and Restoration Project, Project Number C9-996101-009-01; Contract Control # 02 667 5000 0007

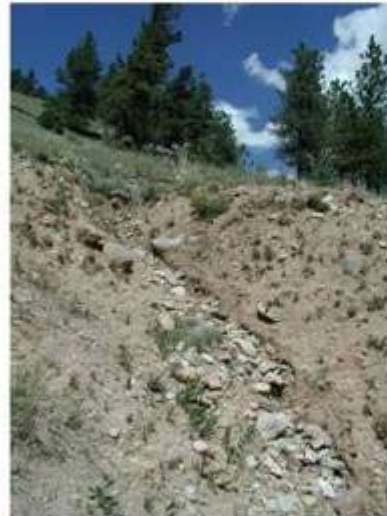
HPP#2
UTM
471941/4075032
Road cut erosion

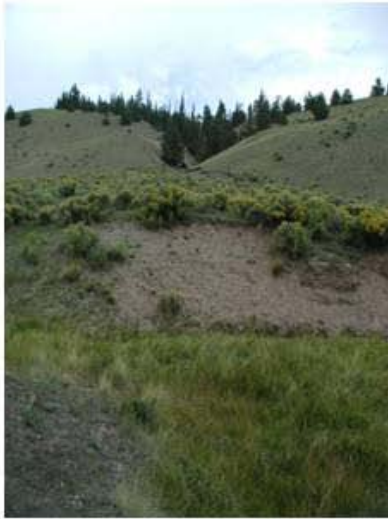
HPR#14 UTM 472351/4074045 side cut stopped by vegetation

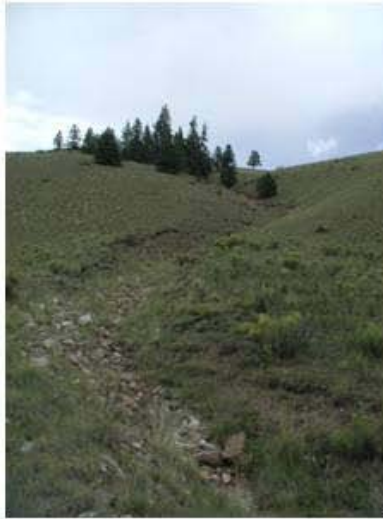
HPR#15 UTM 472351/4074045 side cut stopped by vegetation

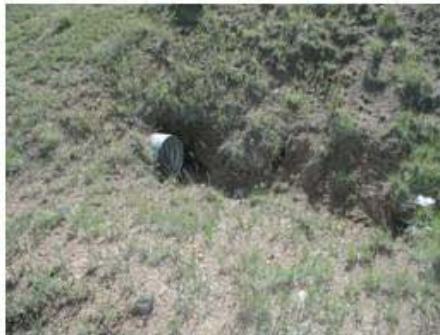
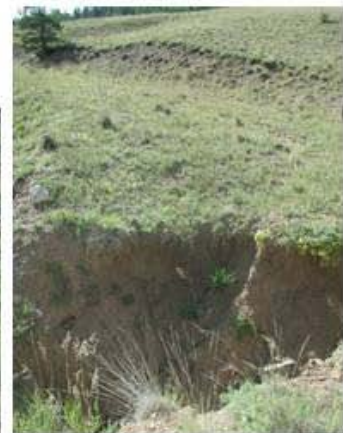
HPR #17-19 UTM 4728773/4073025 culvert/erosion

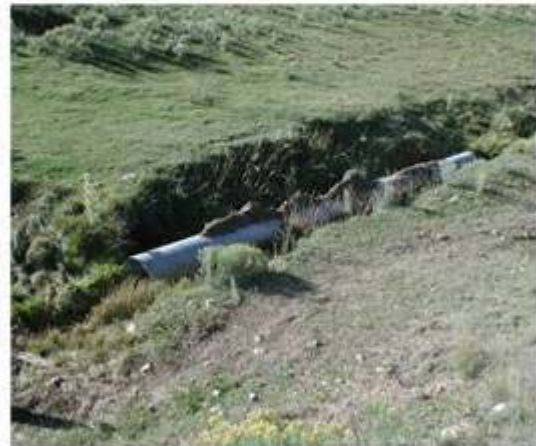
HP#23 Exposed Culvert

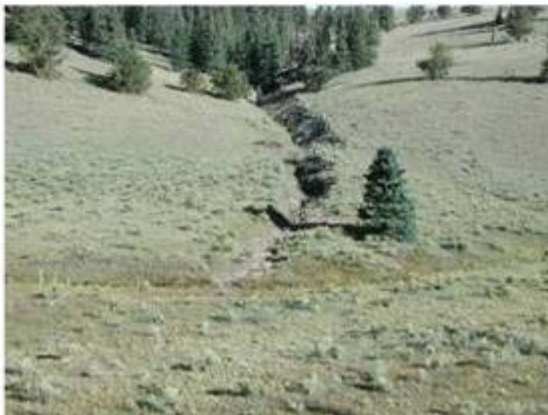
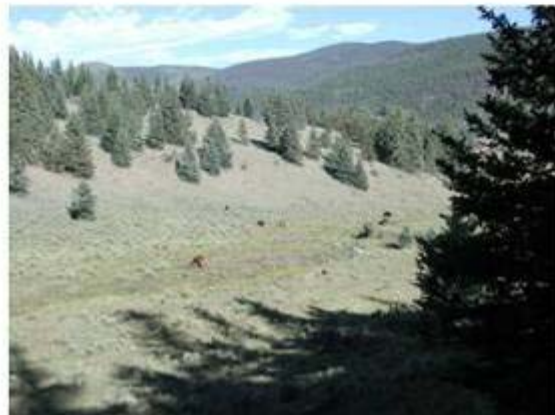
(HPP#24) MMP#3 UTM 474506/4072853 Photo taken from road above side drainage, valley bottom 50-60% utilization, cattle need to be moved, cattle spread out though valley, grazing on slopes light to moderate, some trailing up slope **HPP#25** grazing cattle

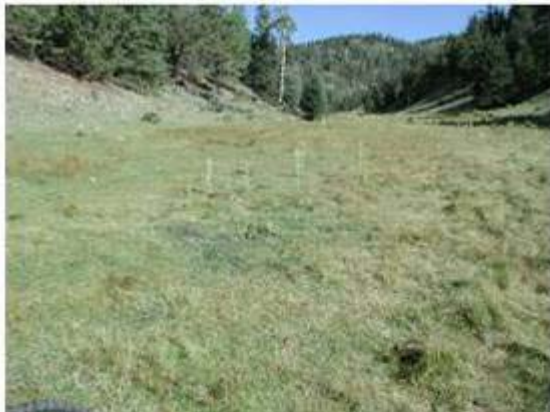
HPP #28 Little Costilla—N—grazing moderate to heavy

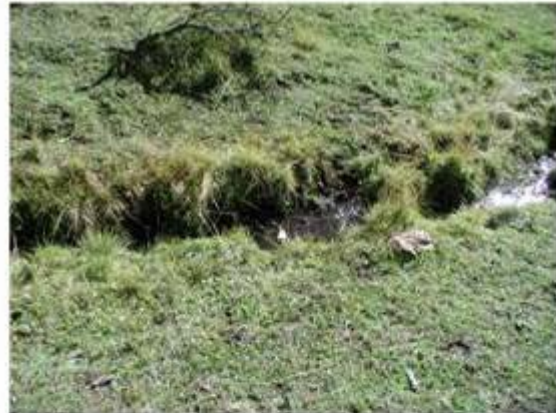
HPP #29 UTM 47 4965/4073822 Grazed creek bank, overgrazed by cattle & elk

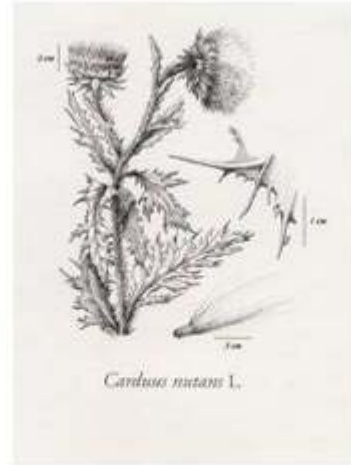
UTM 474172/4075903 Canada thistle

HPP#46 (MPP#5) UTM 476129/4069641 eroded bank Canada thistle browsed along trail UTM 76465/4069833 Small spruce trees growing in creek; Zeedyk erosion controls needed on road along creek/big and small side cuts

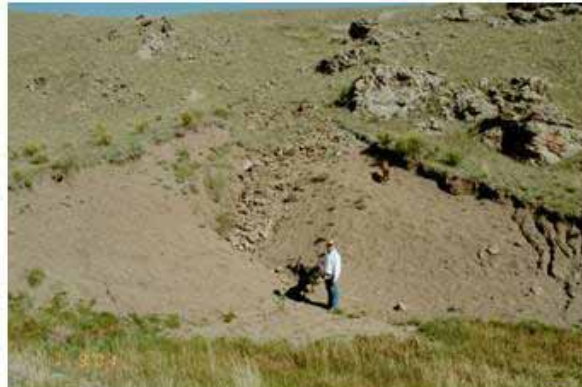
HPP#57 UTM 0475694/4069004 320 degrees NW 9300 ft. First split in La Belle UTM 0475405/4069170 Cattle everywhere; gate and fence down.

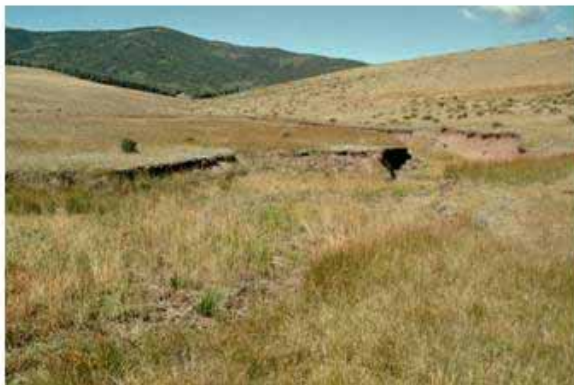
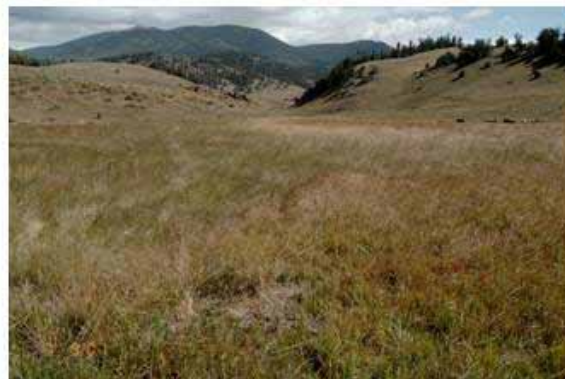
Photo points La Belle below Labelle Lodge. Cut and rills into wet meadow complex. No water above, wet below, cattle grazing. **HPP#58** 9333 Ft. (260 degrees W) **HPP#59** UTM 0475109/4068849 (30 degrees NNE)

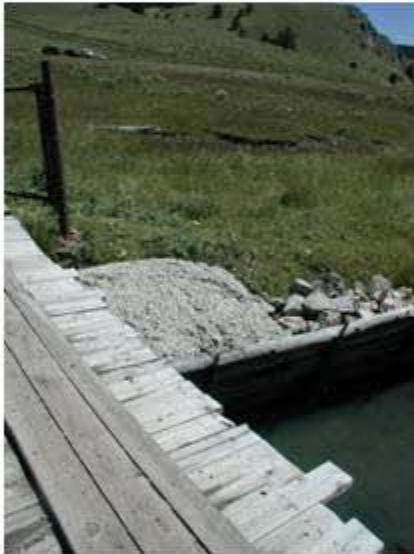
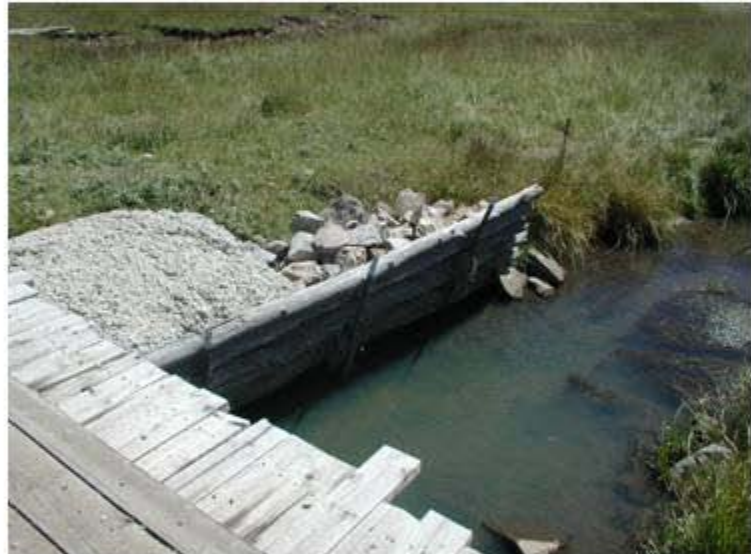
HPP #70-71 Bank stabilization structure at bridge crossing Comanche Creek.

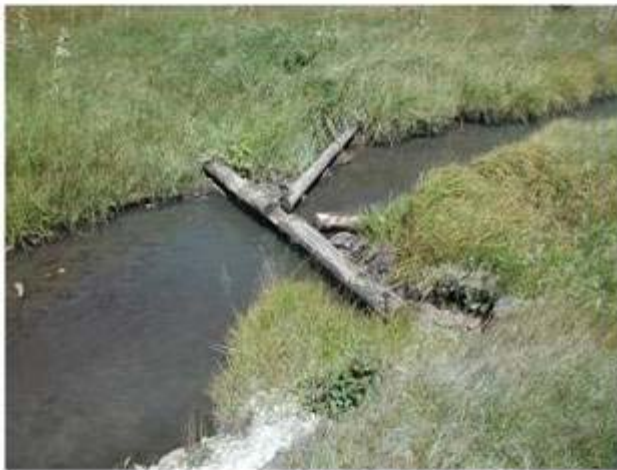
HPP#75 old erosion control structure

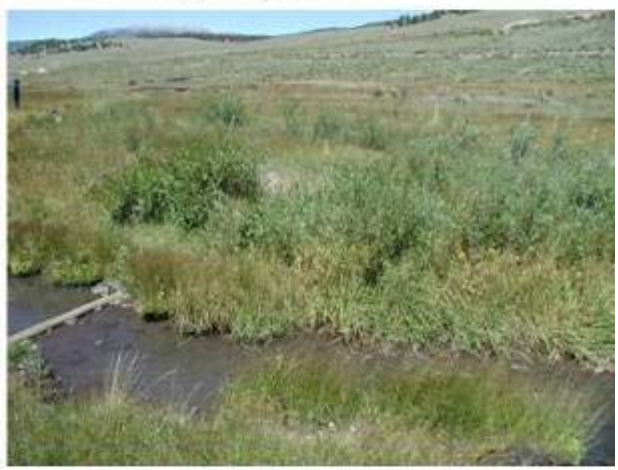
- The large livestock and elk enclosure has not been effective for elk. The gate into the enclosure is of standard height. Aspen regeneration on the upper portions of the enclosure was dramatic compared to the area outside the fence, but little difference in herbaceous cover was noted. Willow regeneration was also noted in the enclosure.

HPP#76 Willows growing in elk ex-closure

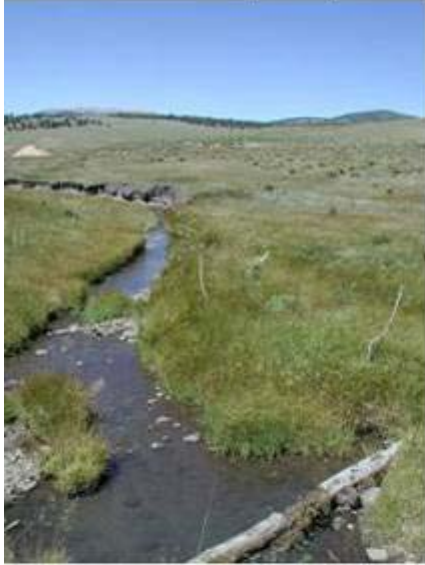
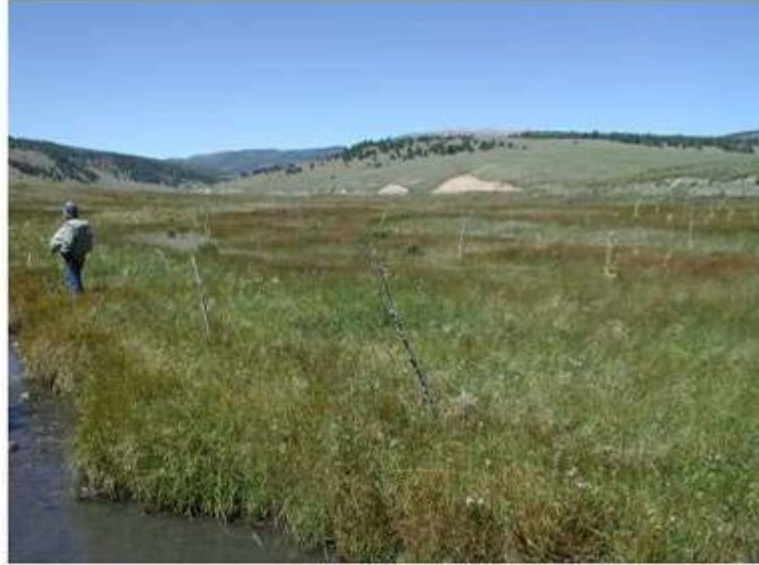
HPP#78-79 Dead Pole plantings

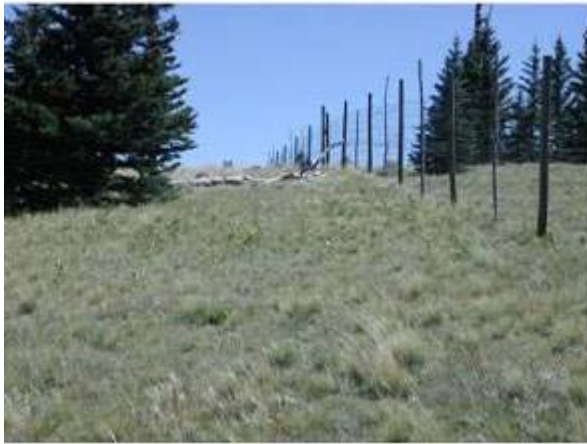
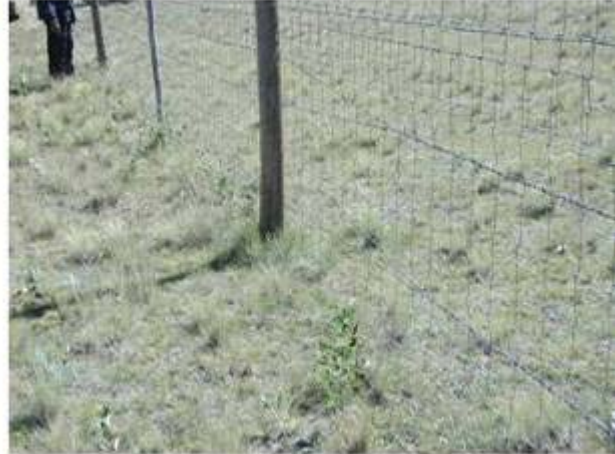
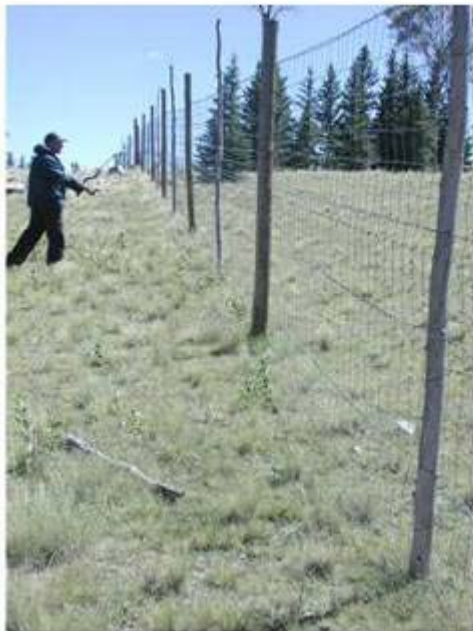
- The large livestock and elk enclosure has not been effective for elk. The gate into the enclosure is of standard height. Aspen regeneration on the upper portions of the enclosure was dramatic compared to the area outside the fence, but little difference in herbaceous cover was noted. Willow regeneration was also noted in the enclosure.

HPP#83-85 UTM 474736/4070603 Aspen regeneration on inside of elk enclosure
Is this MTE soil? Change in vegetation Thurber Fescue?

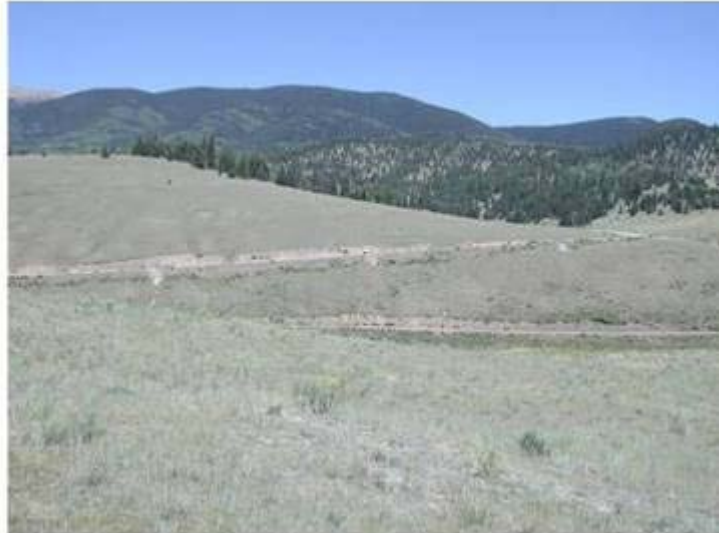
HPP #86 Culverts
